Building Condition Assessment  
Yarmouth Fire Hall  
Yarmouth, Nova Scotia

TOWN OF YARMOUTH

PROJECT NO. 1021439

**March 28, 2007**

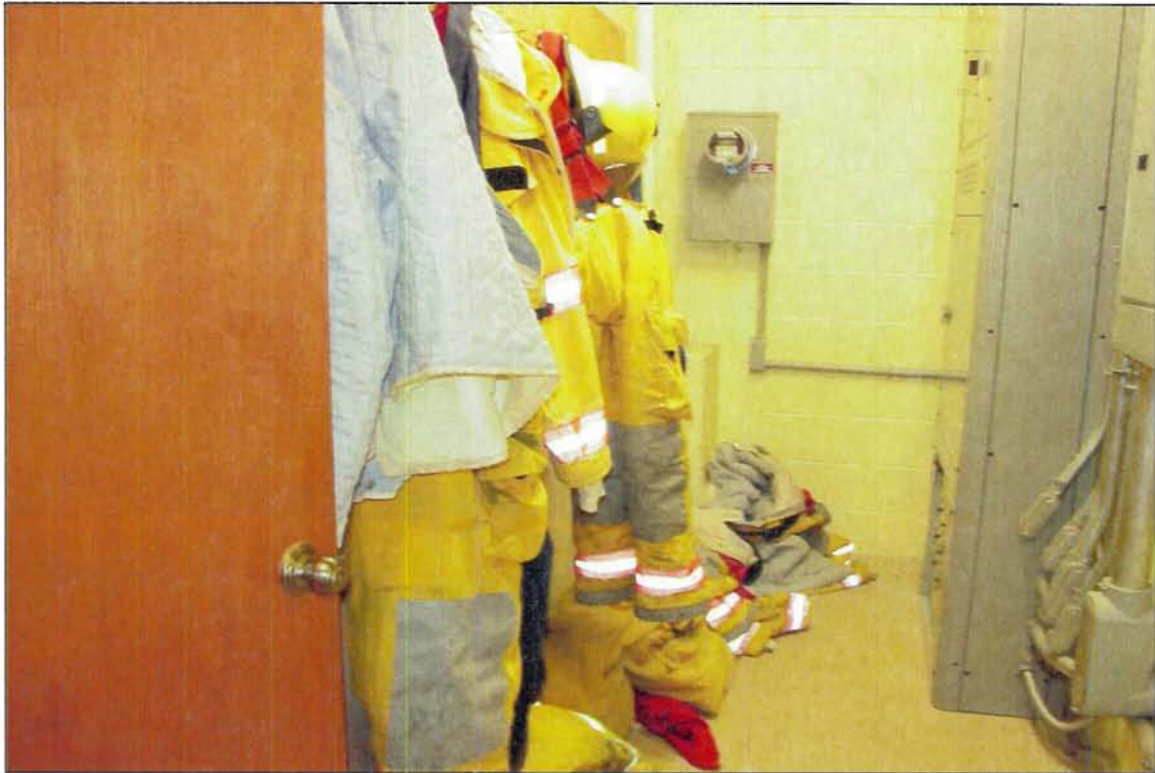
Photo 1 - View Of Electrical Room

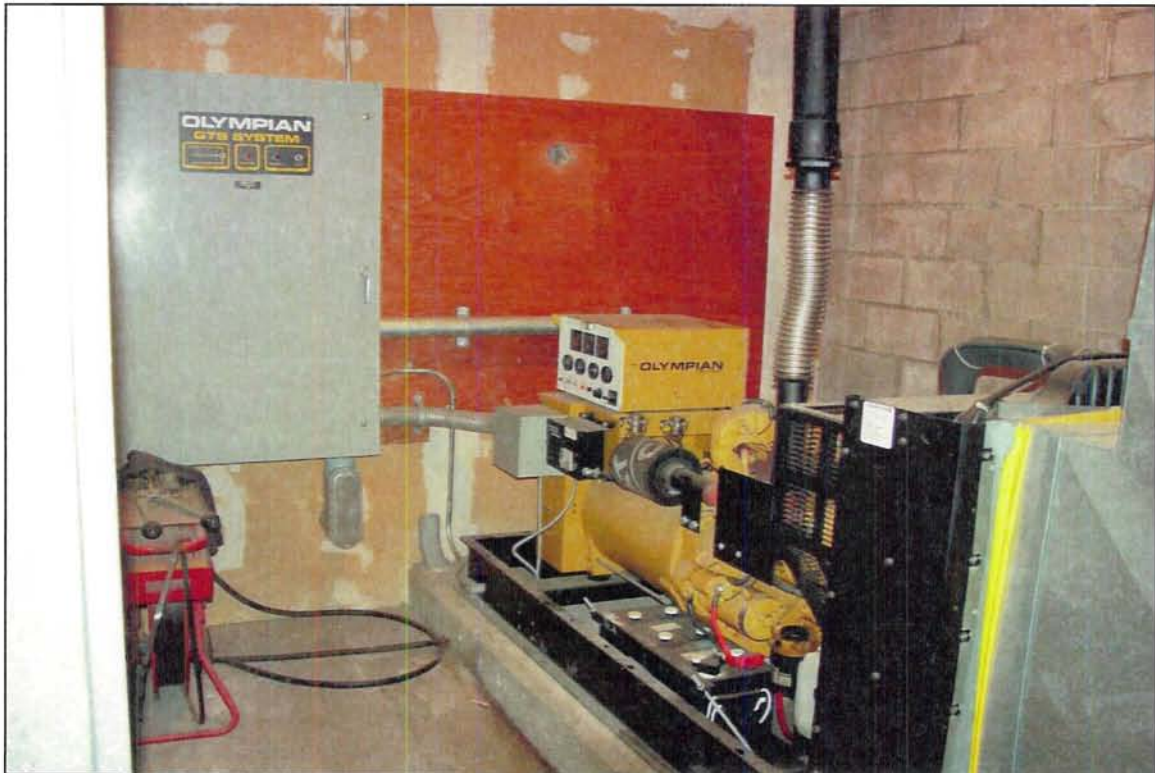
Photo 2 - View of Diesel Generator Room

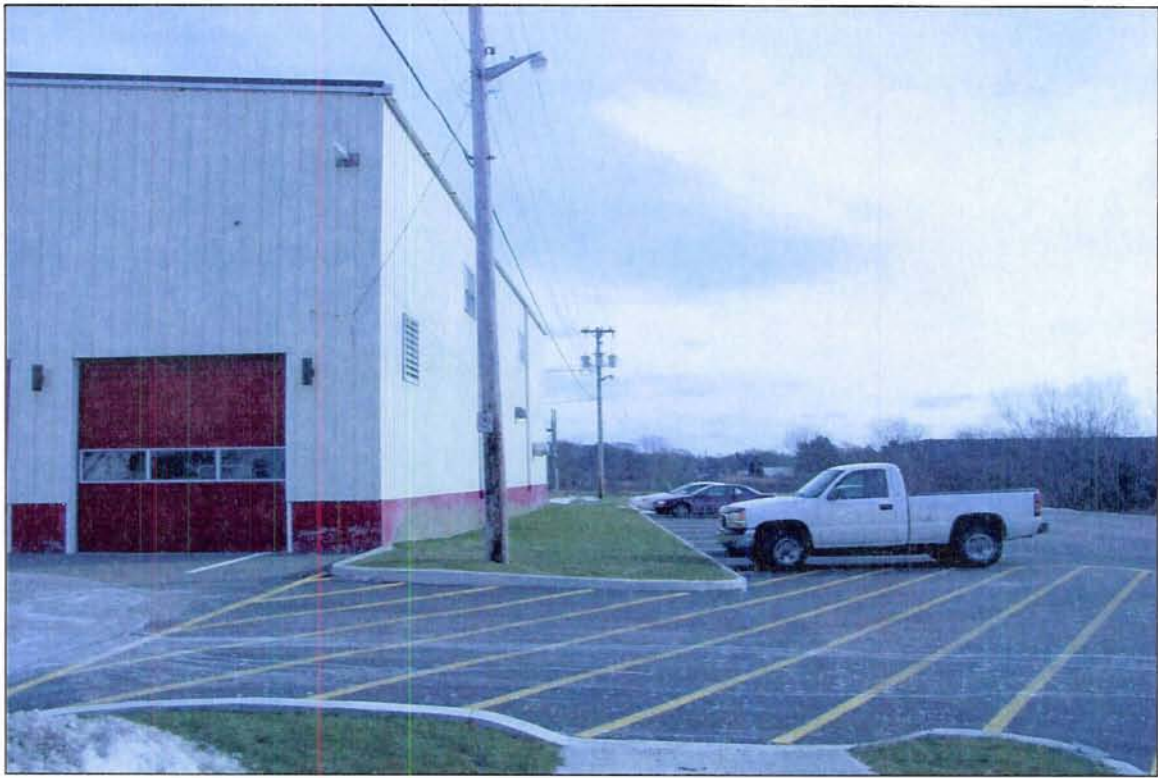
**Photo 3 - View Of Exterior Lighting On South Side Of The Building**

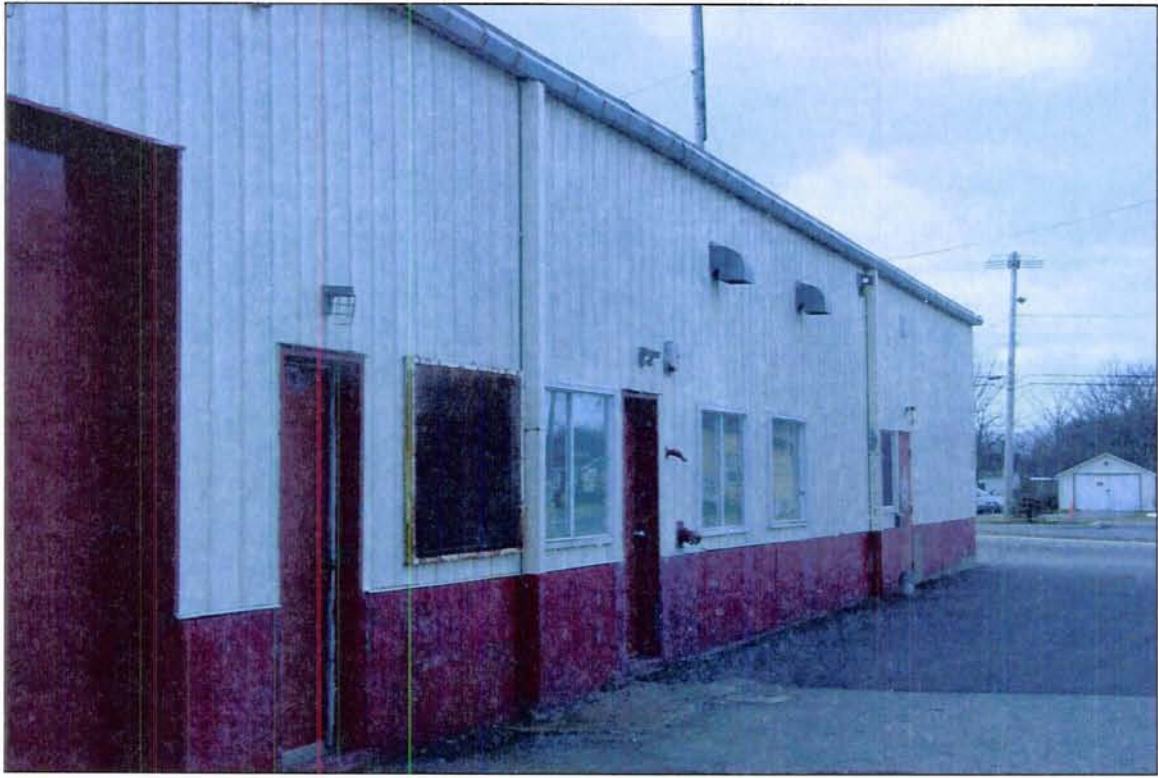
**Photo 4 - View Of Exterior Lighting On North Side Of The Building**

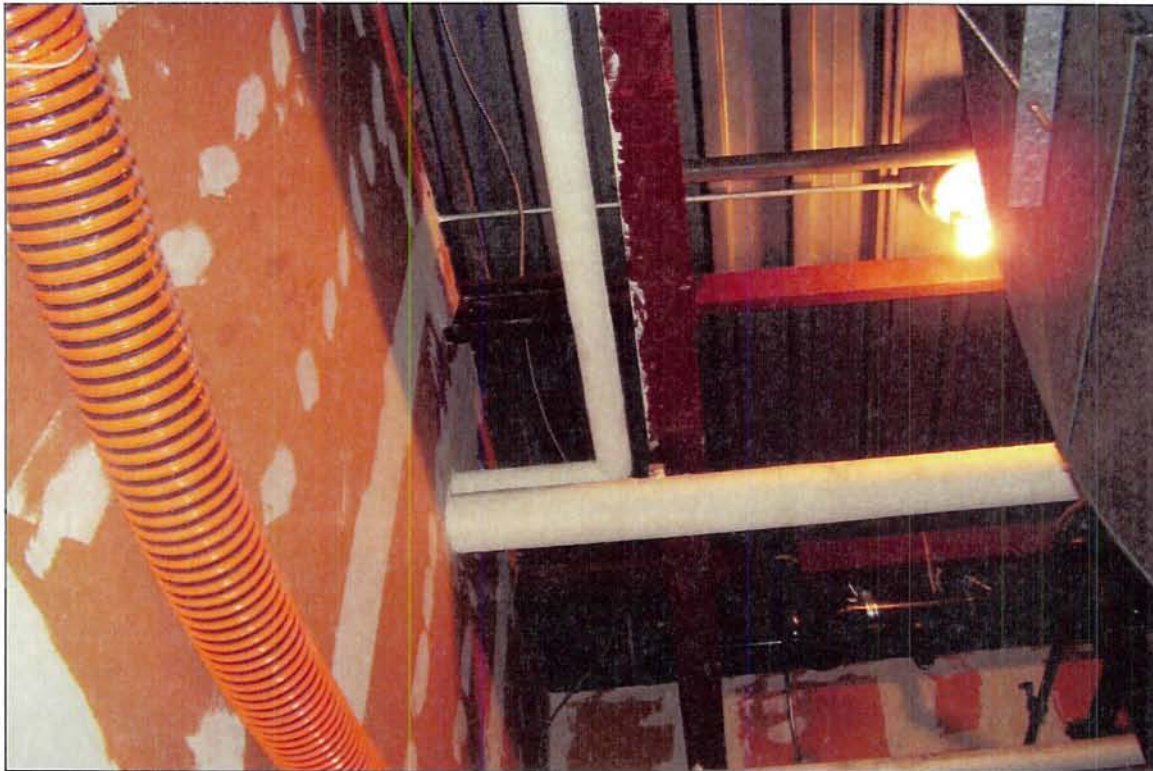
**Photo 5 – Exposed Structural Steel Framing In The Mechanical Room**

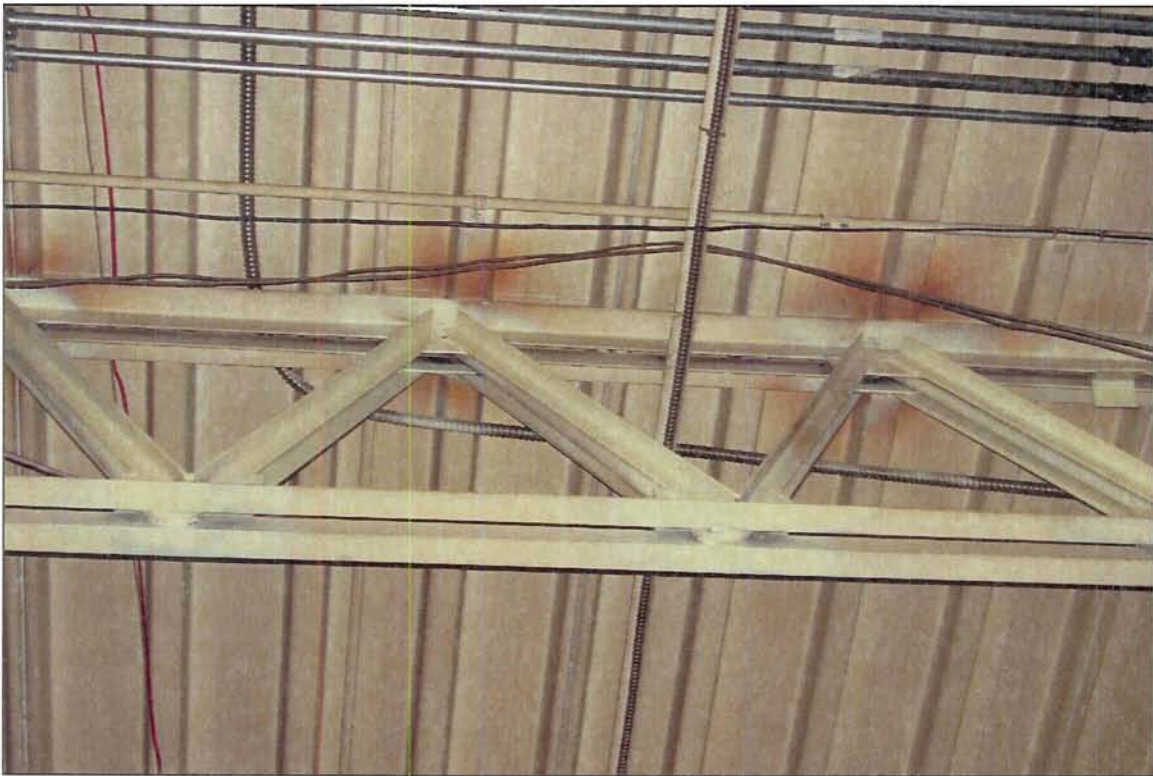
**Photo 6 – Typical Open Web Steel Joist In the Truck Bay**

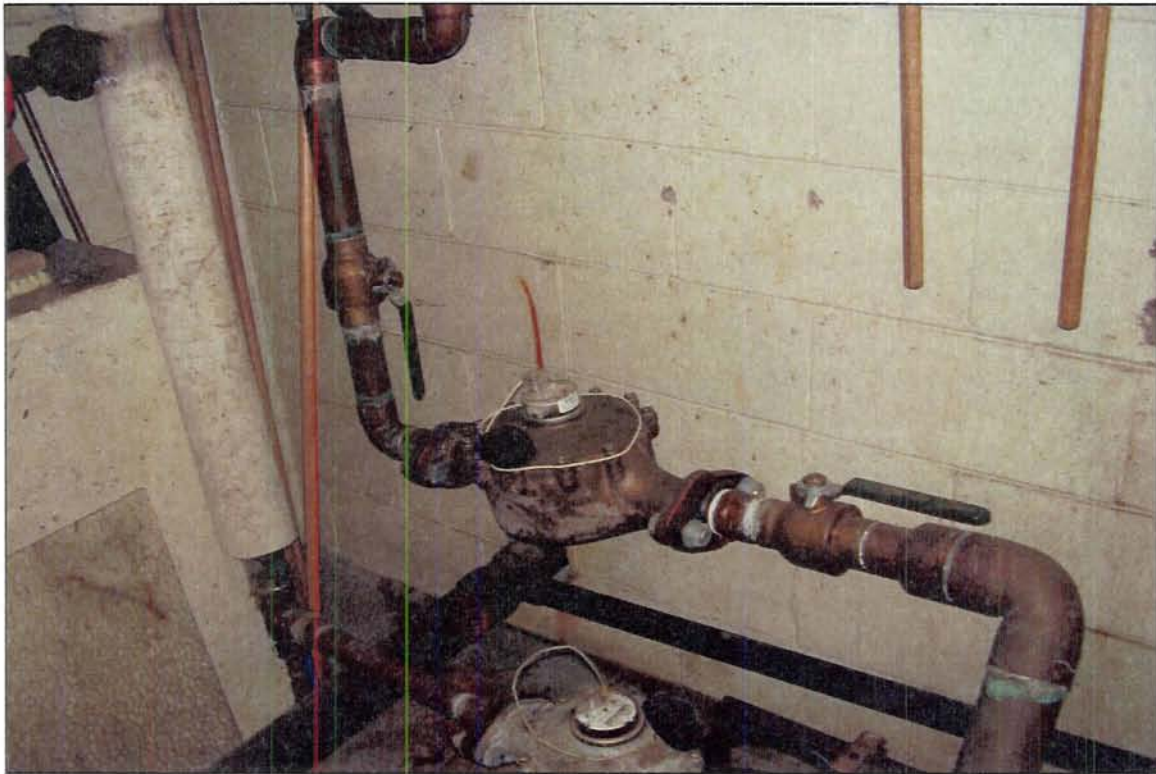
**Photo 7 – View of Water Meter and Entrance**

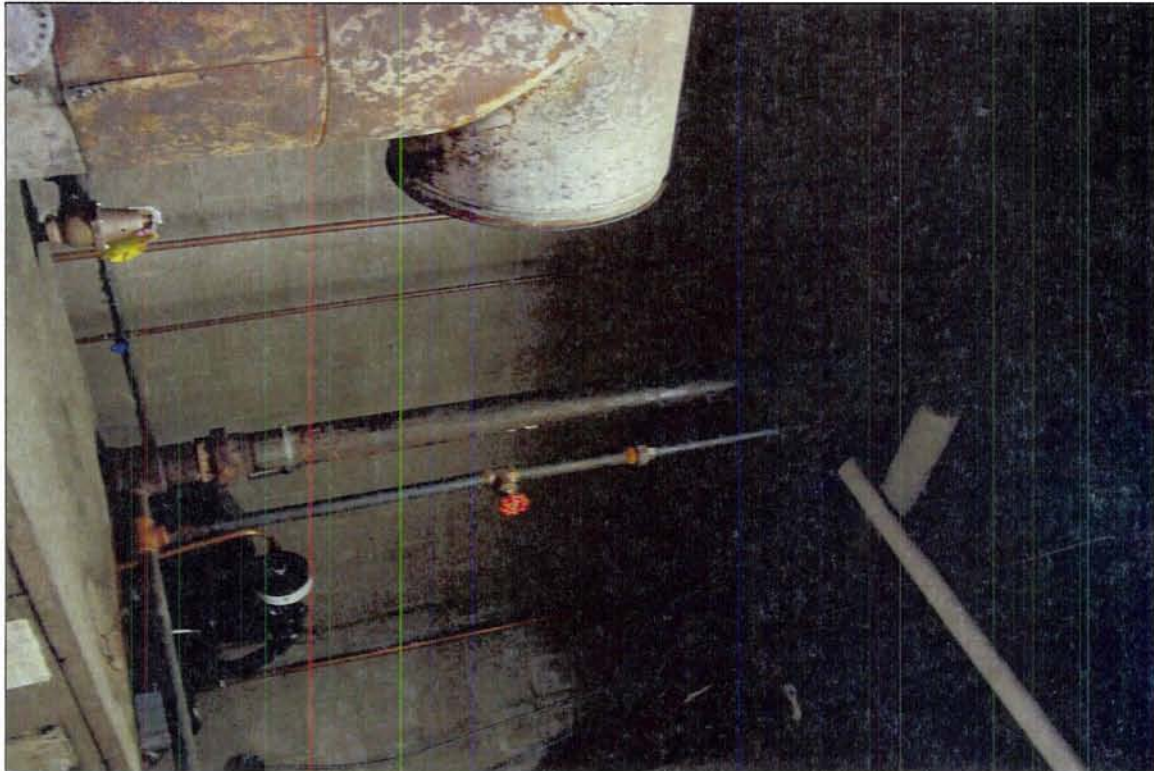
**Photo 8 - Uninsulated Piping And Breeching In Boiler Room**

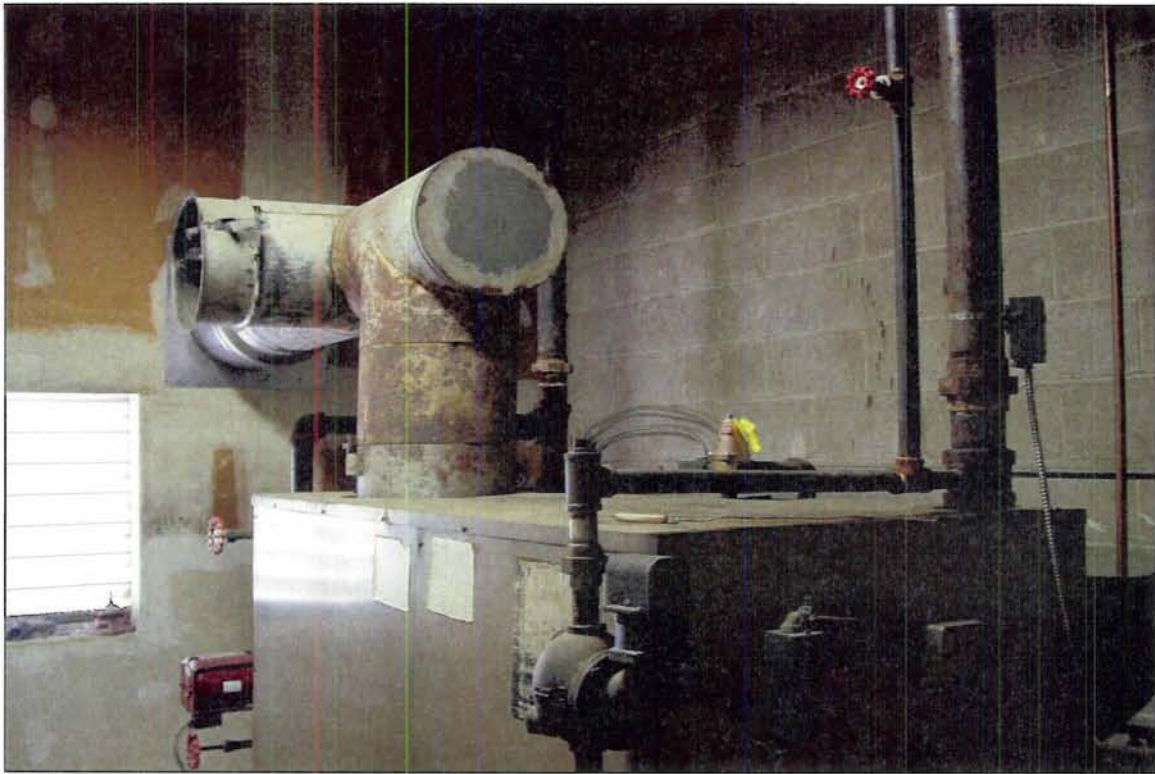
Photo 9 - Existing Boiler

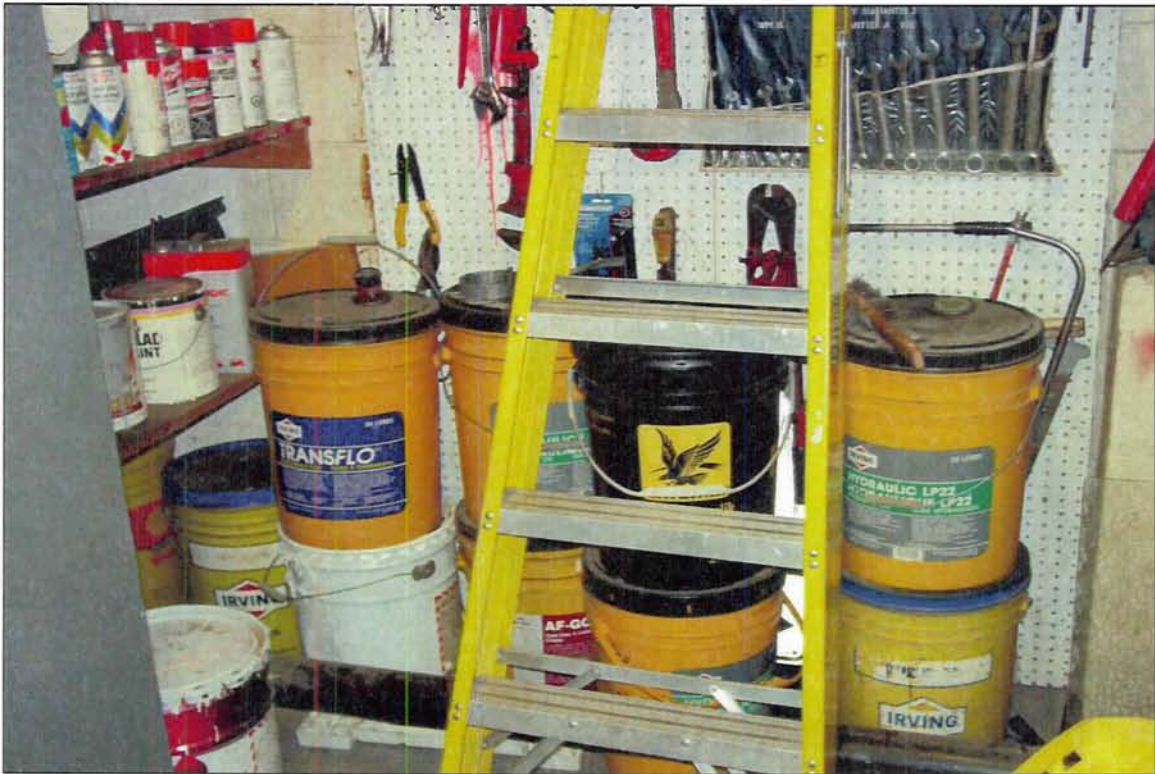
Photo 10 - Paints And Oils Stored In Unventilated Room

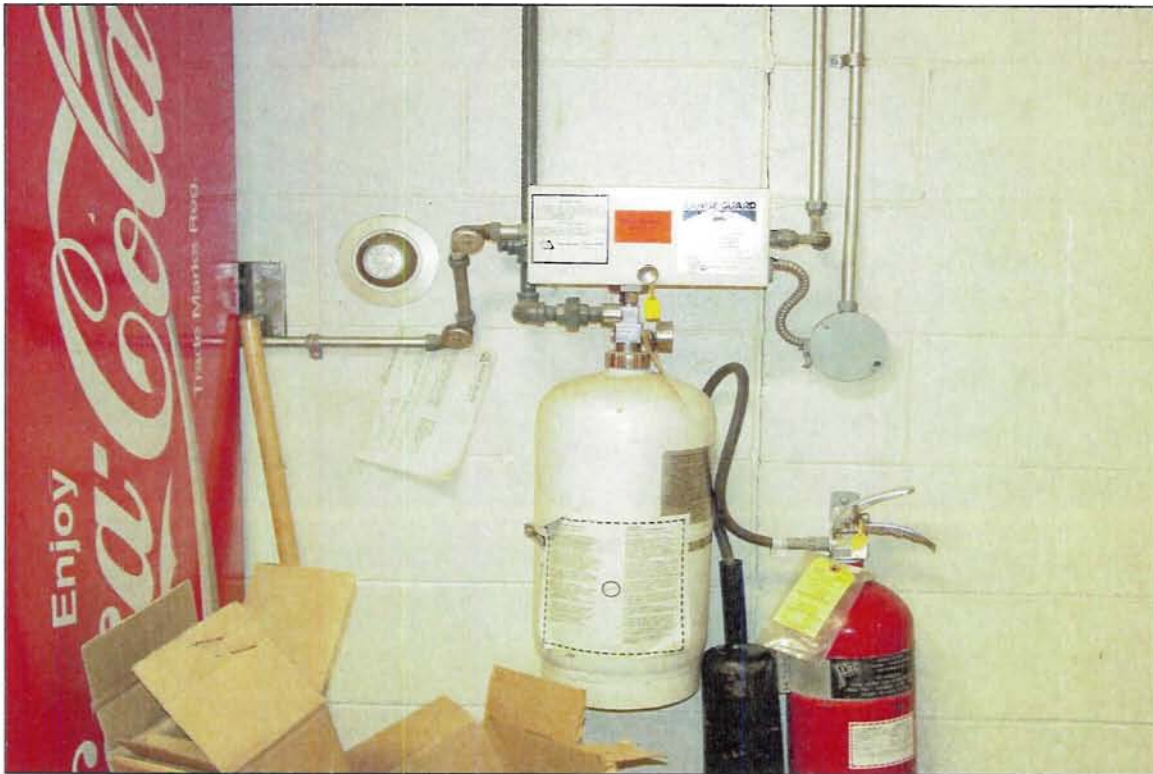
Photo 11 - Manual Activation For Cooktop Fire Suppression System

- Install new sprinkler heads below roll up doors in sprinkler bays;
- Relocate kitchen exhaust hood manual activation;
- Replace water extinguishers with multi purpose extinguishers;

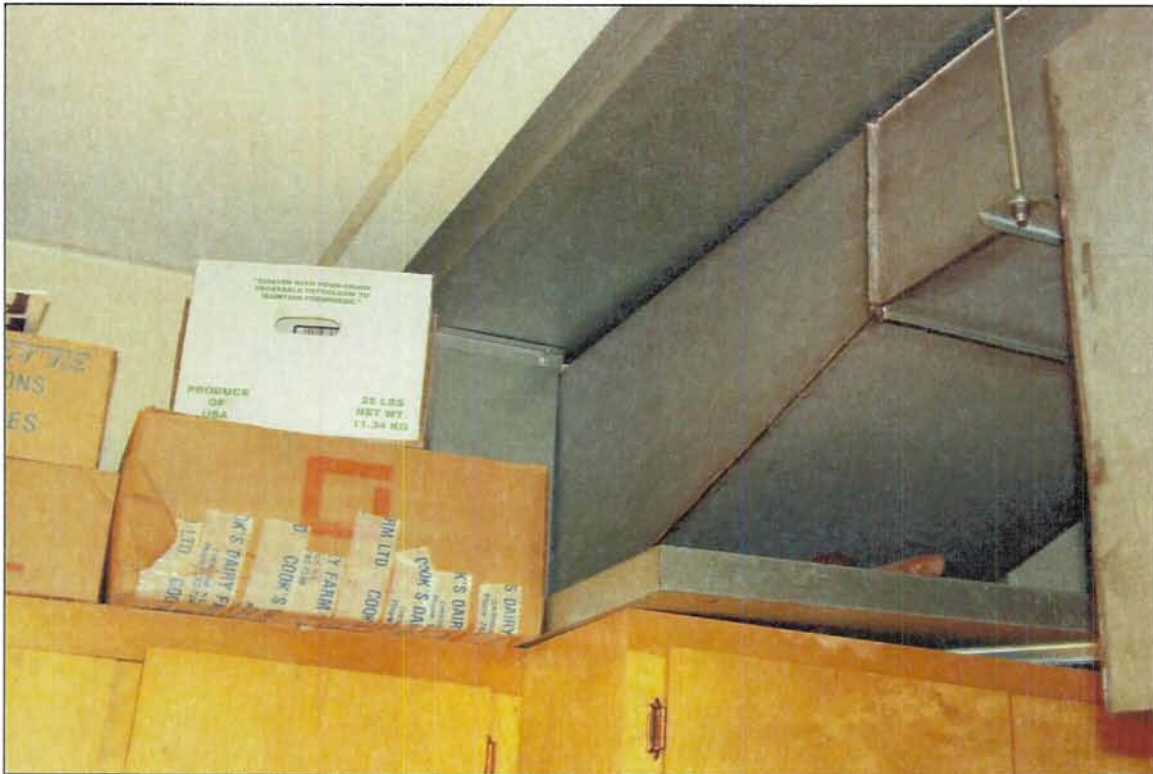
Photo 12 - Combustibles In Proximity To Grease Duct

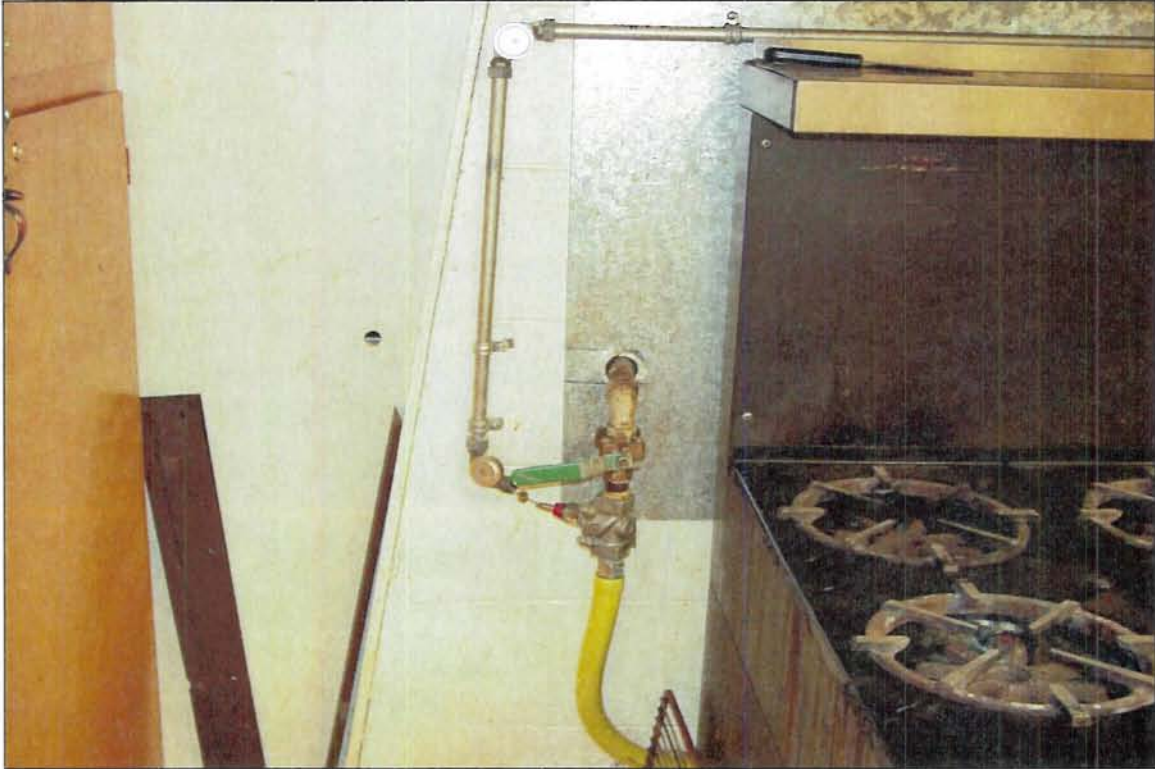
Photo 13 - No Label On Propane Shut Off

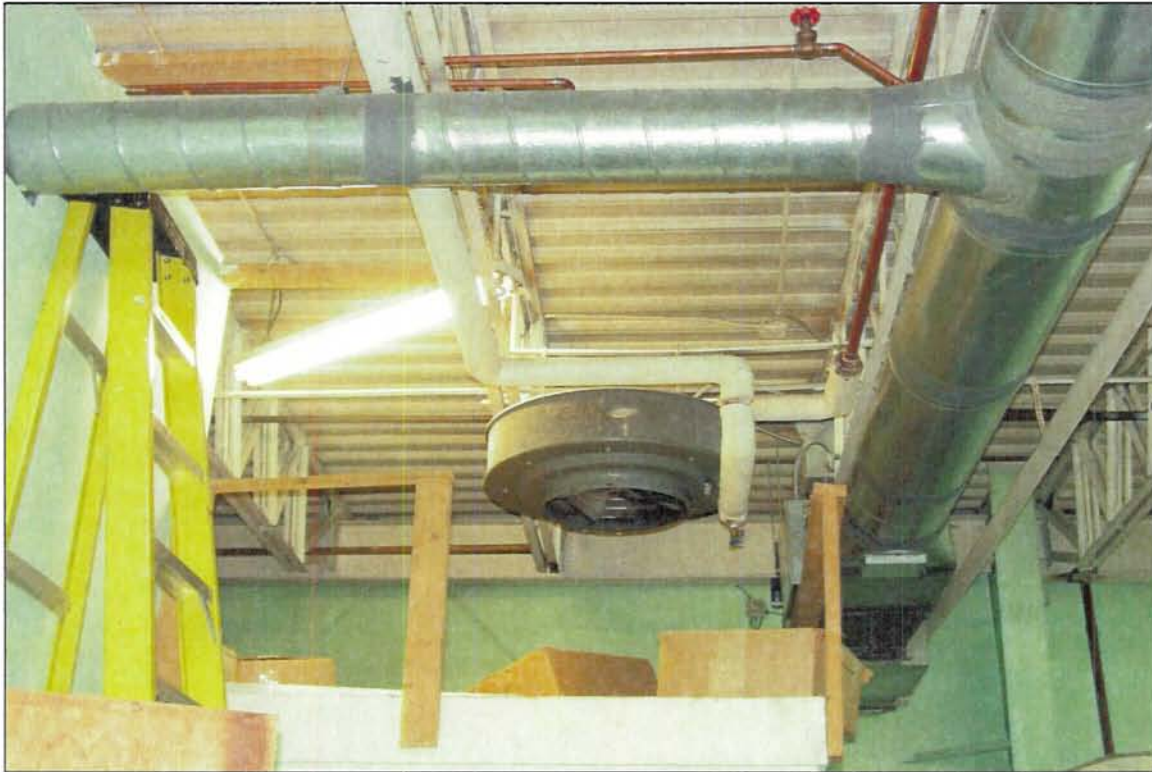
Photo 14 - Unit Heater Over Mezzanine On Main Floor

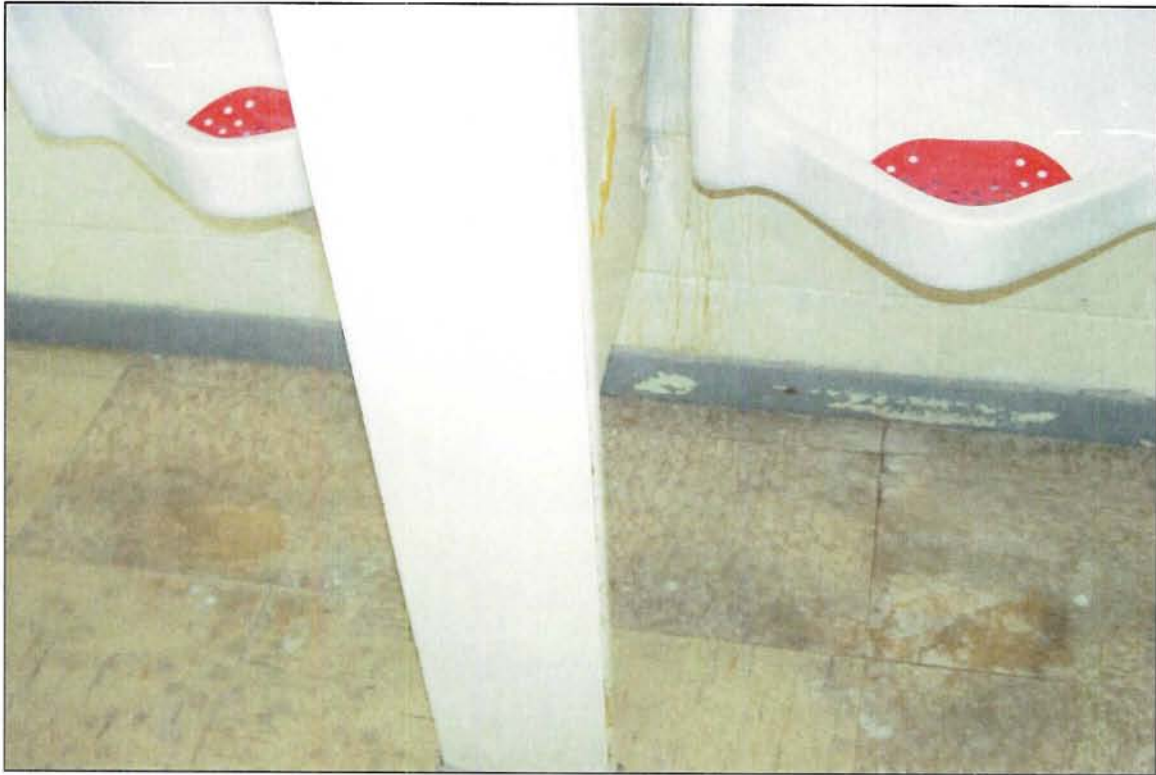
**Photo 15 - Evidence Of Past Plumbing Leaks In Main Floor Washroom**

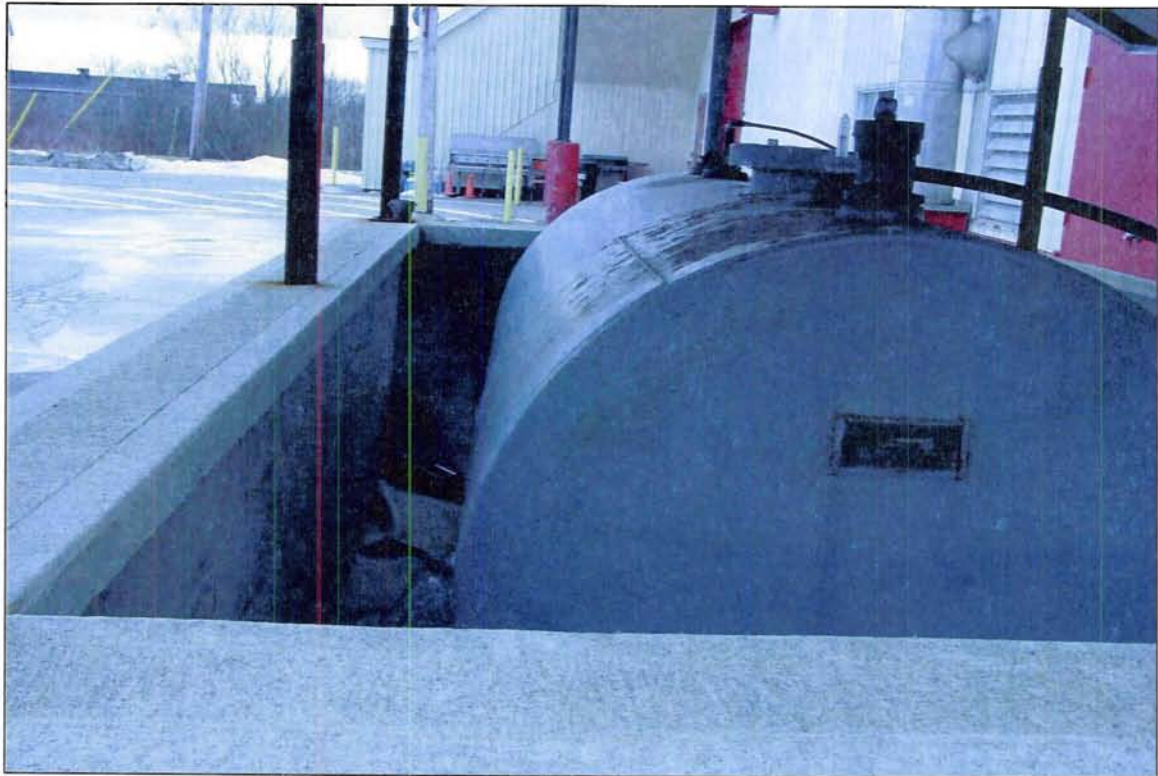
**Photo 16 - AST In Concrete Containment. Note Damaged Liner And Ice Buildup**

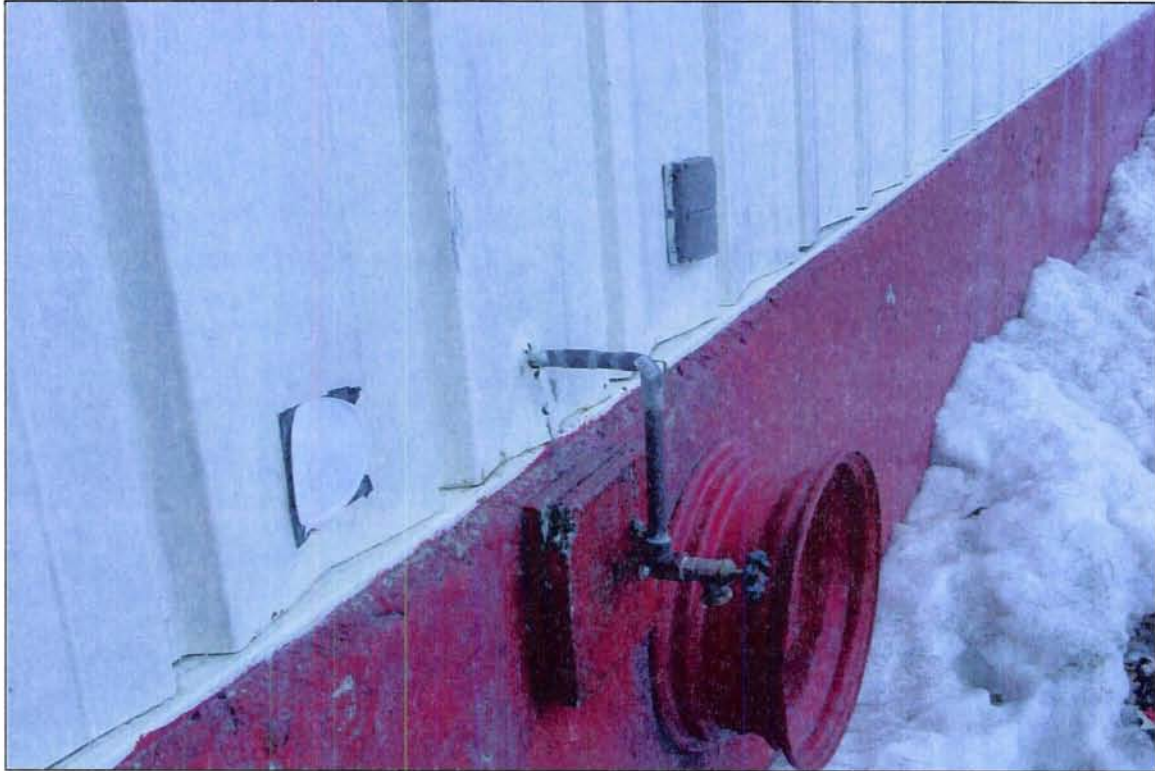
**Photo 17 - Potential Freeze Condition With External Faucet**

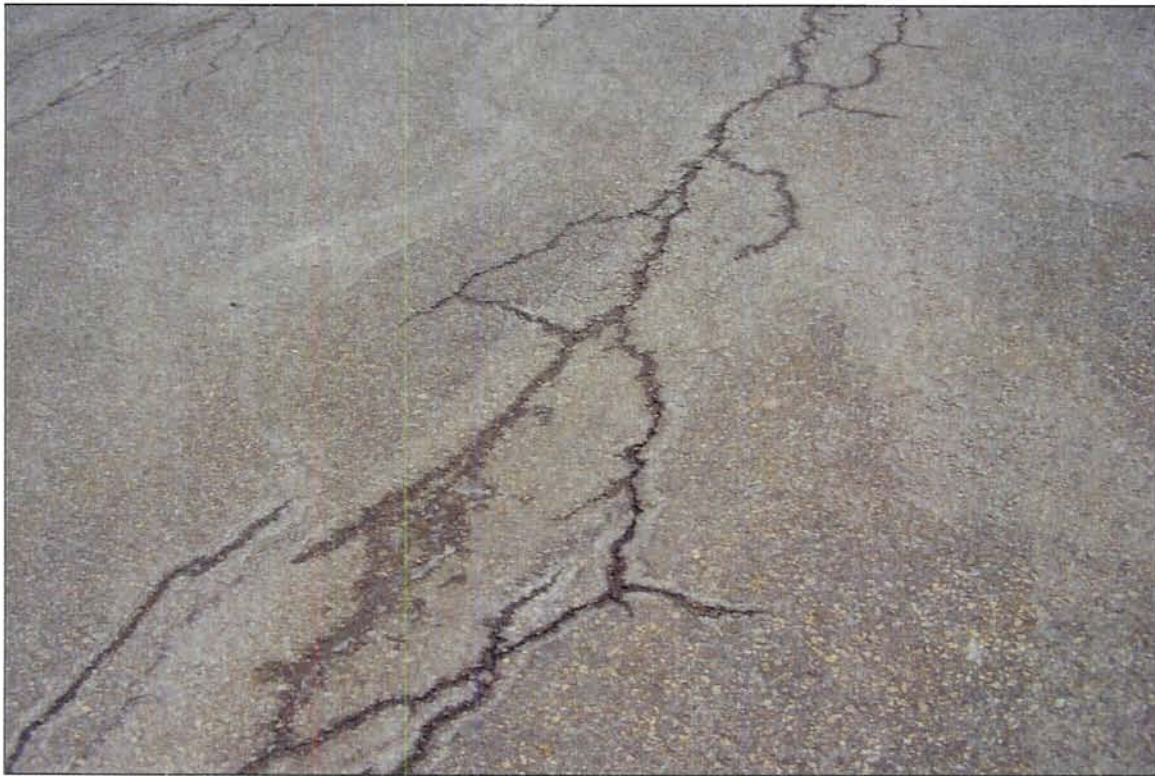
The original asphalt-paved surfaces at the rear of the property are in poor condition with severe alligator cracking and pot holes apparent, indicating that the sub base material has likely been compromised. Longitudinal cracking was observed in the fire truck entrance of Pleasant Street. Concrete curbing was observed to be in good condition overall.

**Photo 18 - Alligator Cracking In Asphalt**

- 1) Full depth asphalt replacement should be completed at the original asphalt pavement sections on the east side of the site.

This is a priority 2 recommendation with a cost estimate of \$27,000.

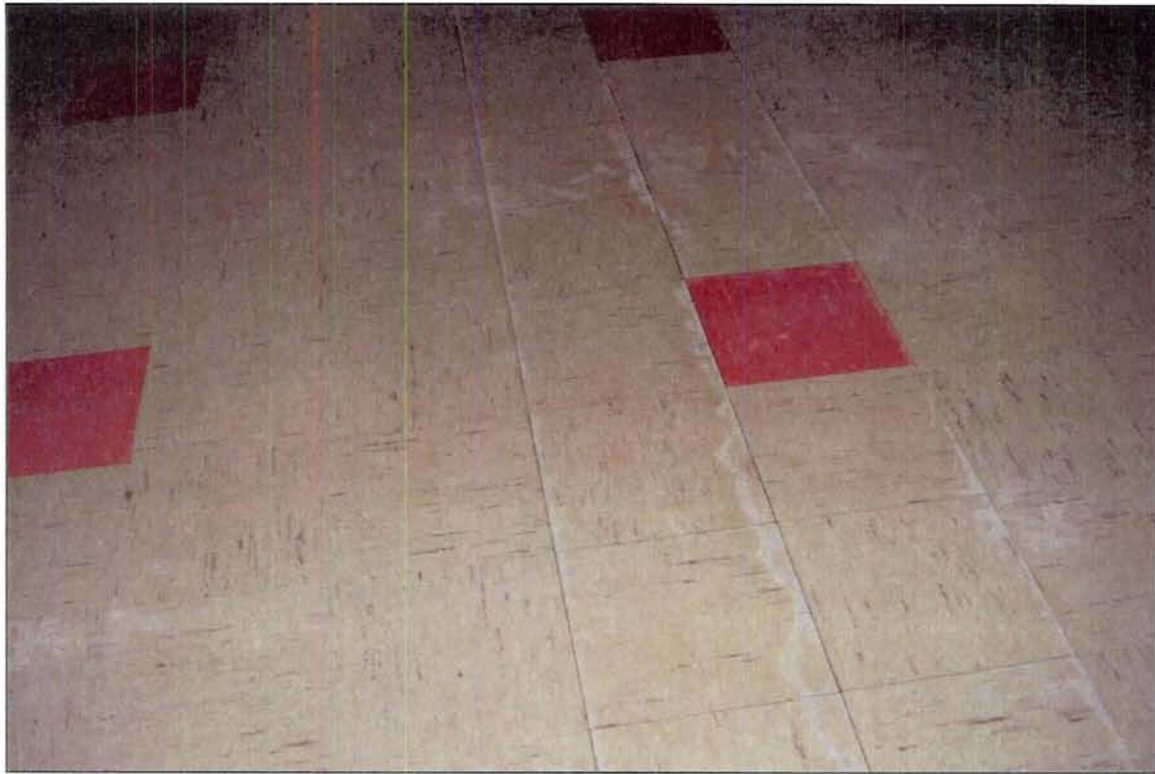
On the second floor, cracks in the concrete floor have telegraphed through the VCT flooring and, in some cases, holes in the concrete are visible. Through the course of the site visit movement or 'bounce' was observed in the open Hall area.

**Photo 19 - Cracking In The Second Floor**

- 3) Expose and repair the voids and holes in the concrete over metal pan on the second floor level. This applies to the cracking in the Hall area and the kitchen floor.

This is a priority 1 recommendation with a cost estimate of \$1 000.

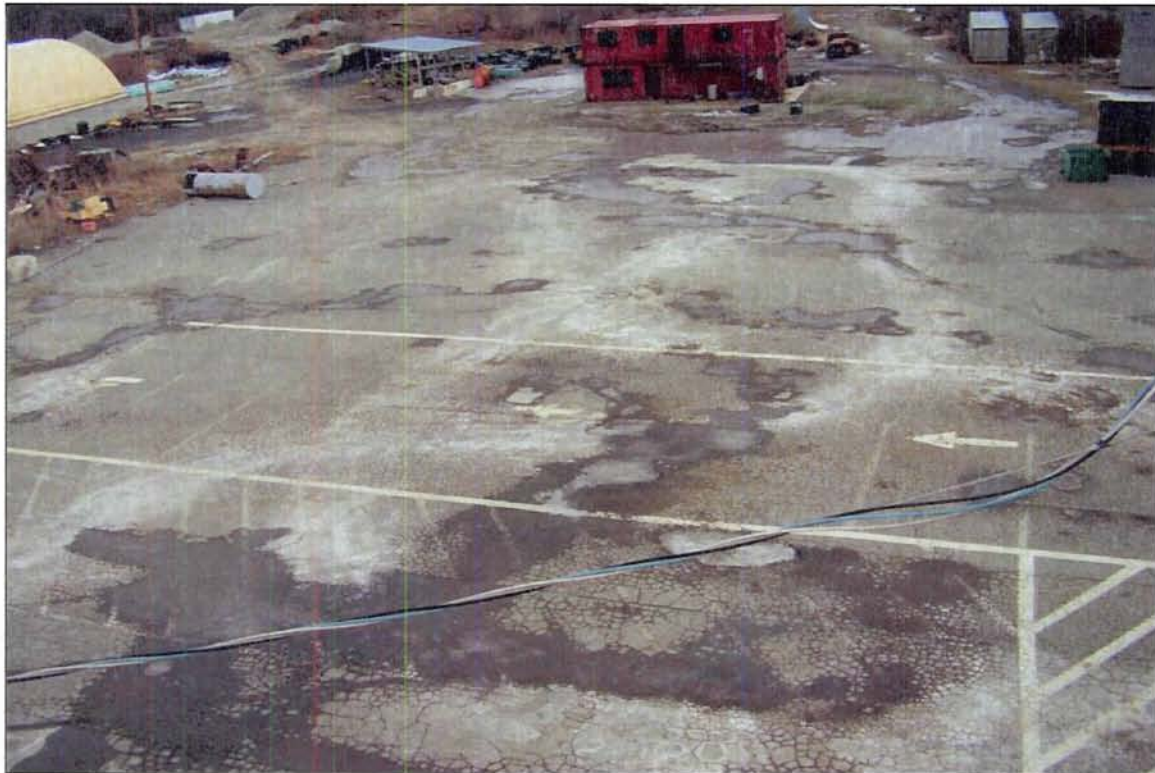
**Photo 20 - Overall Condition Of Asphalt Pavement As Seen From The Roof**

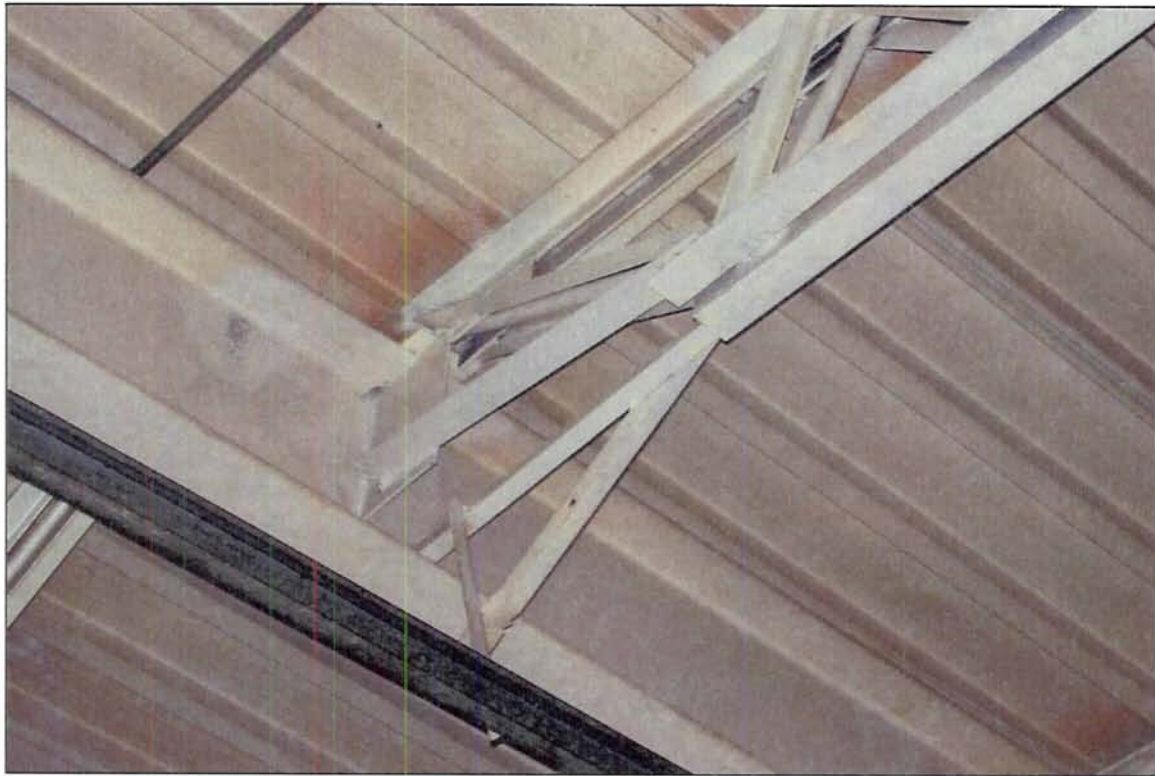
**Photo 21 - Typical Joist To Beam Connection**

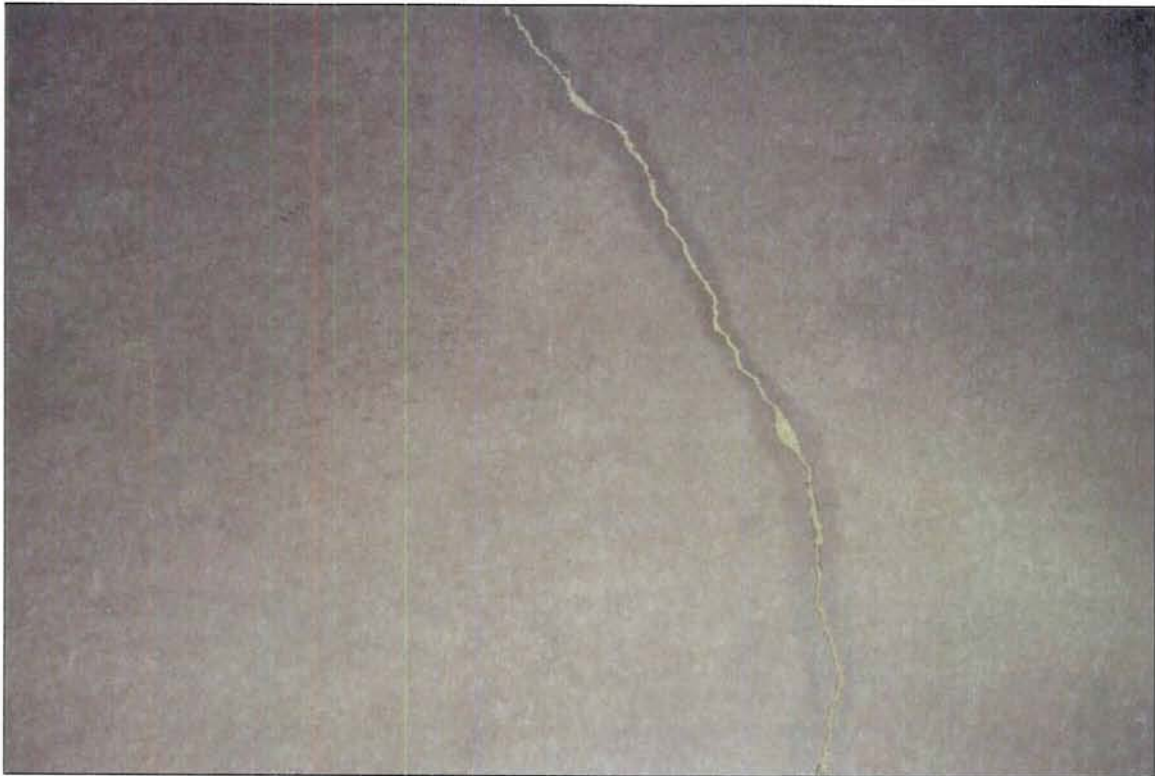
The exposed concrete slab on the ground floor (slab-on-grade) has clear indications of cracking and in some cases minor differential movement has occurred. Cracking is also evident around column and pier bases where lack of control joints and proper slab joints are evident. The concrete slab has been painted in the past and is in need of resurfacing preferably with a slip resistant finish. In all areas at the exterior man doors there is significant evidence of water damage and some rust staining on the flooring surface and lifting in areas where the water has penetrated the floor finish.

**Photo 22 - Cracking In The Concrete Floor Slab**

- 4) Repair all significant slab cracking in truck bay area by cutting out the affected crack and sealing the resulting joint with an appropriate mastic.

This is a priority 2 recommendation with a cost estimate of \$4 000.

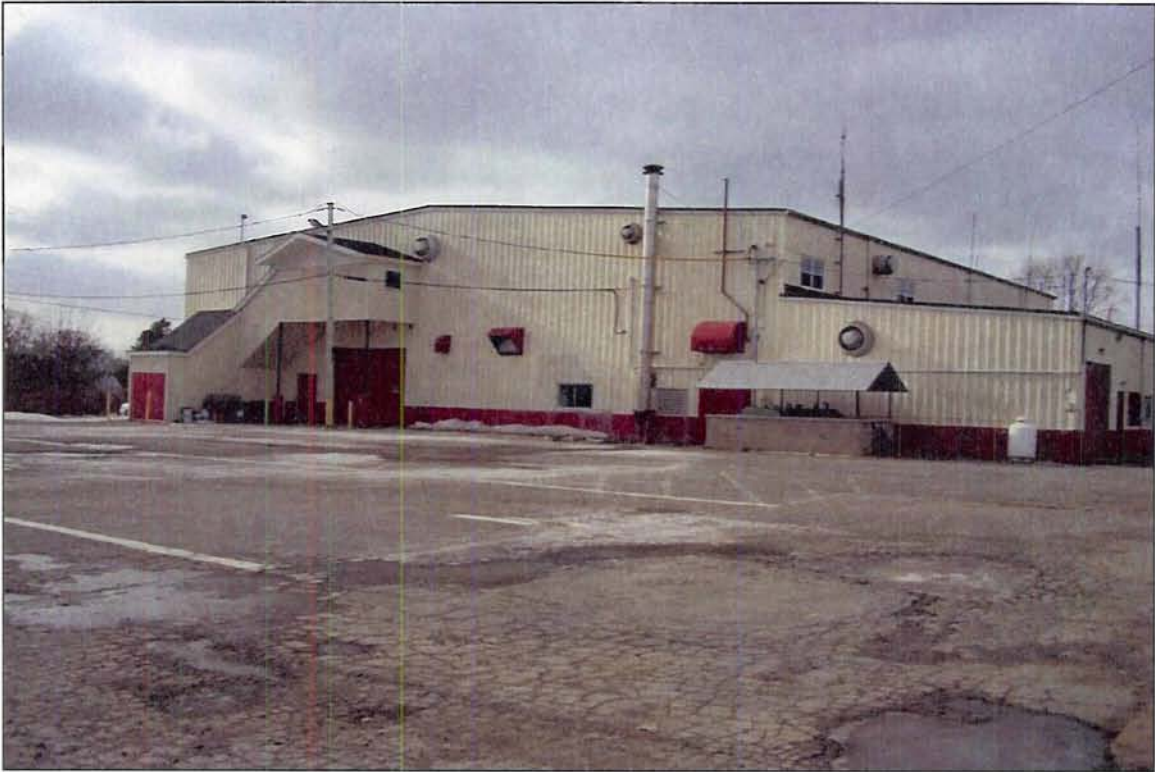
**Photo 23 - East Elevation**

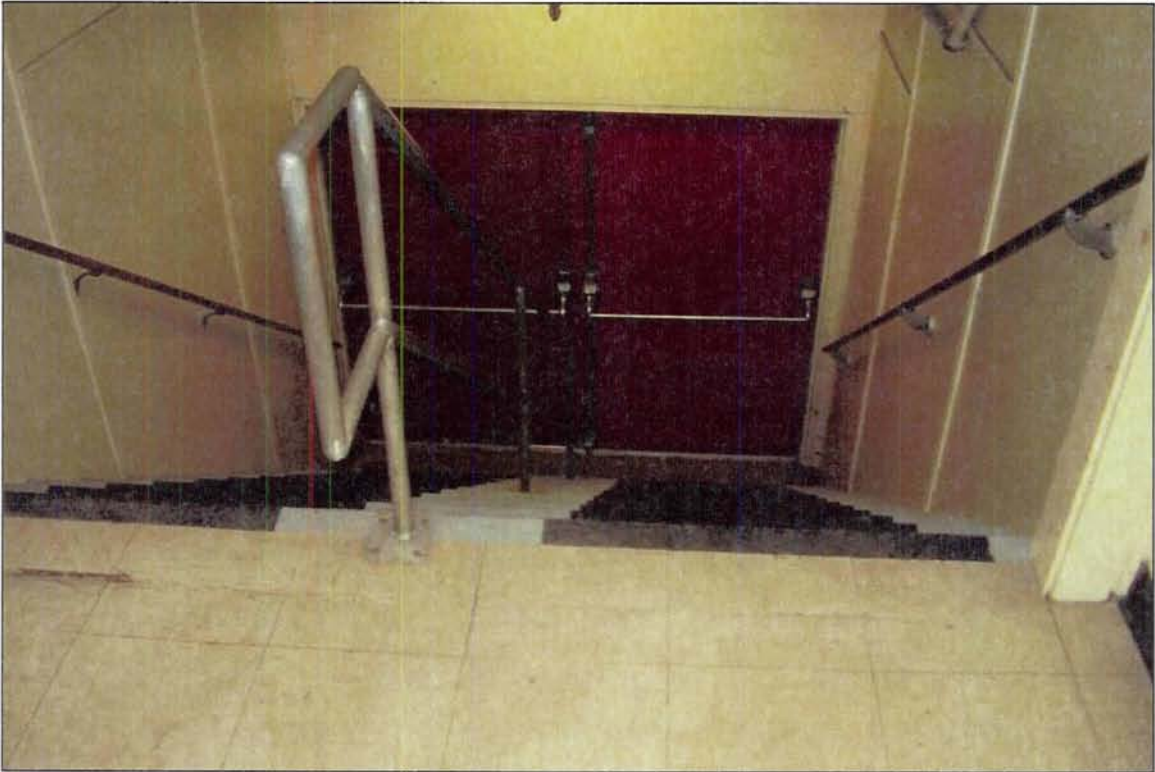
The rear exit stair addition is exhibiting signs of water damage throughout, with areas of loose and deteriorated plywood observed. The underside of the upper landing shows signs of rotting and pulling away from the joists and the steel fascia along the roof line was observed to be rusted and stained.

**Photo 24 - Non-Compliant Egress Stairs At The Rear Of The Building**
