Building Condition Assessment  
Yarmouth Fire Hall  
Yarmouth, Nova Scotia

TOWN OF YARMOUTH

PROJECT NO. 1021439

**March 28, 2007**

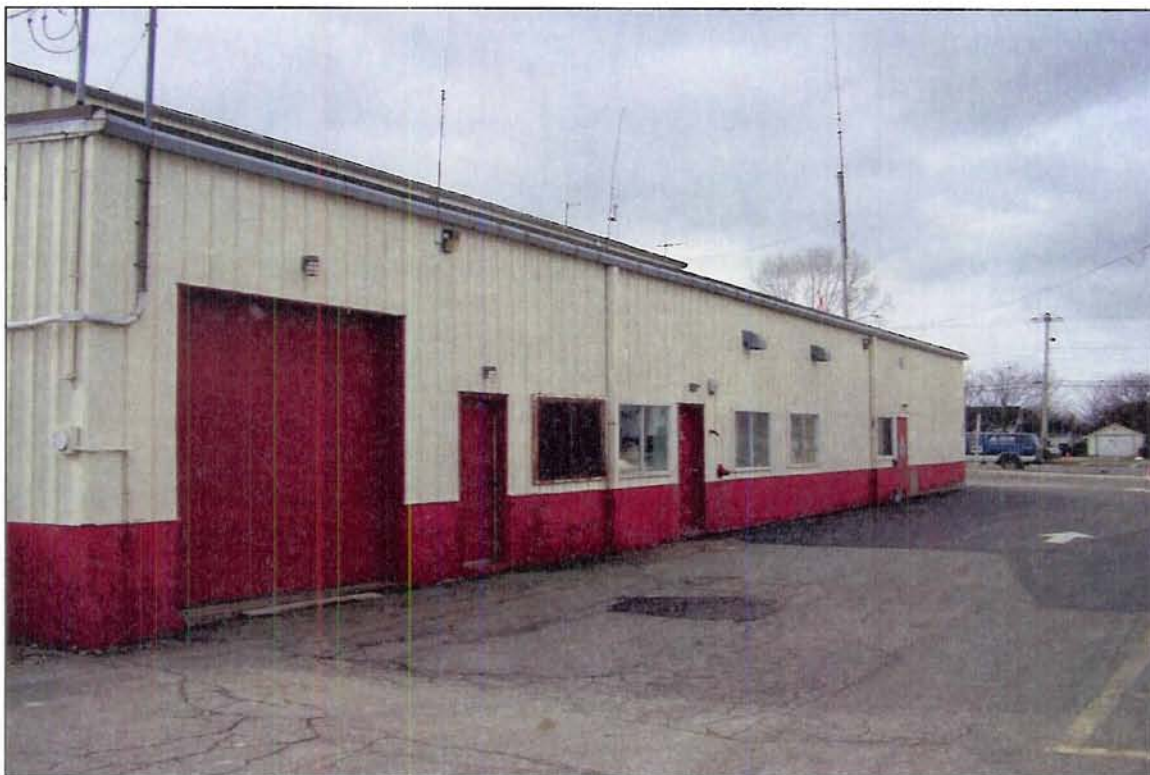
Photo 25 - North Elevation

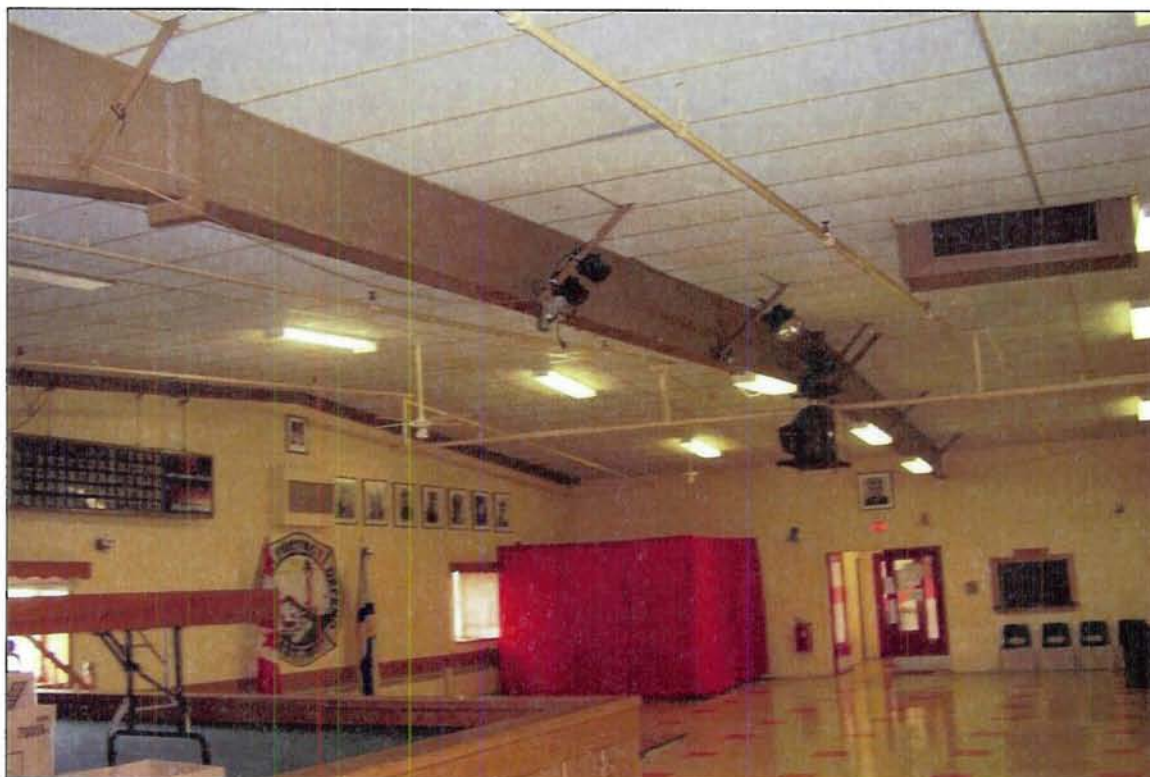
Photo 26 - Second Floor Reception Hall

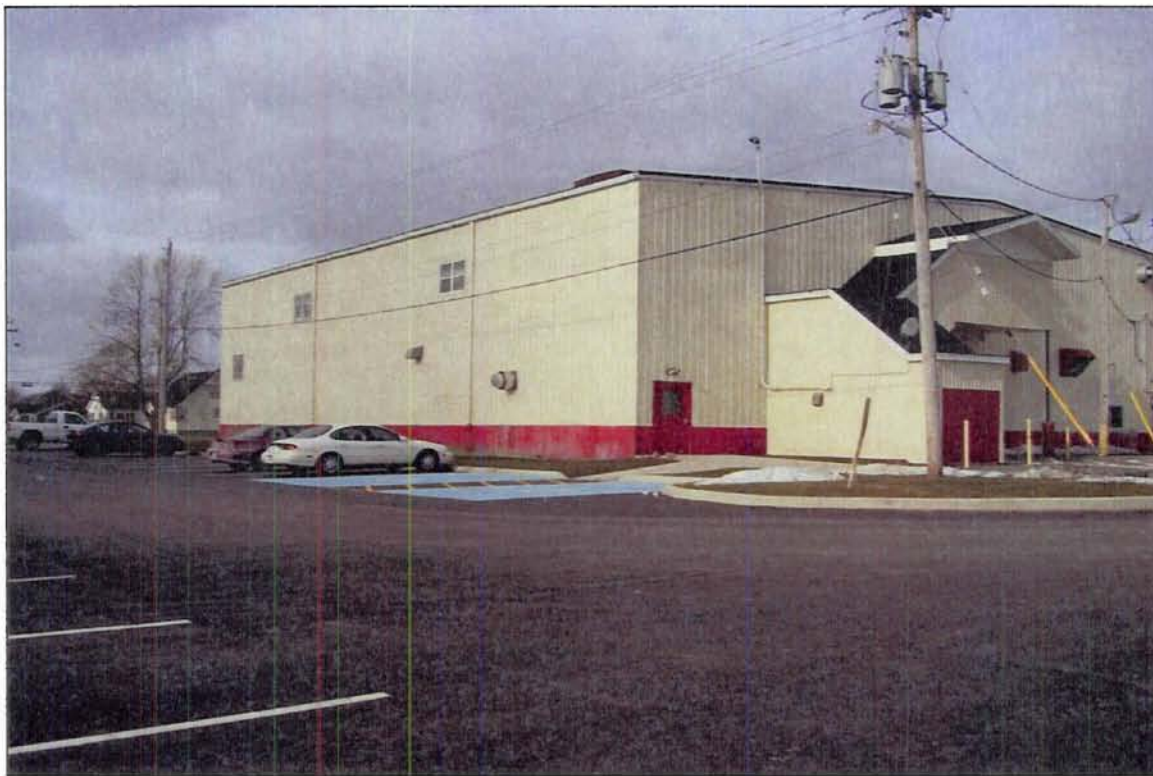
**Photo 27 - South Elevation**

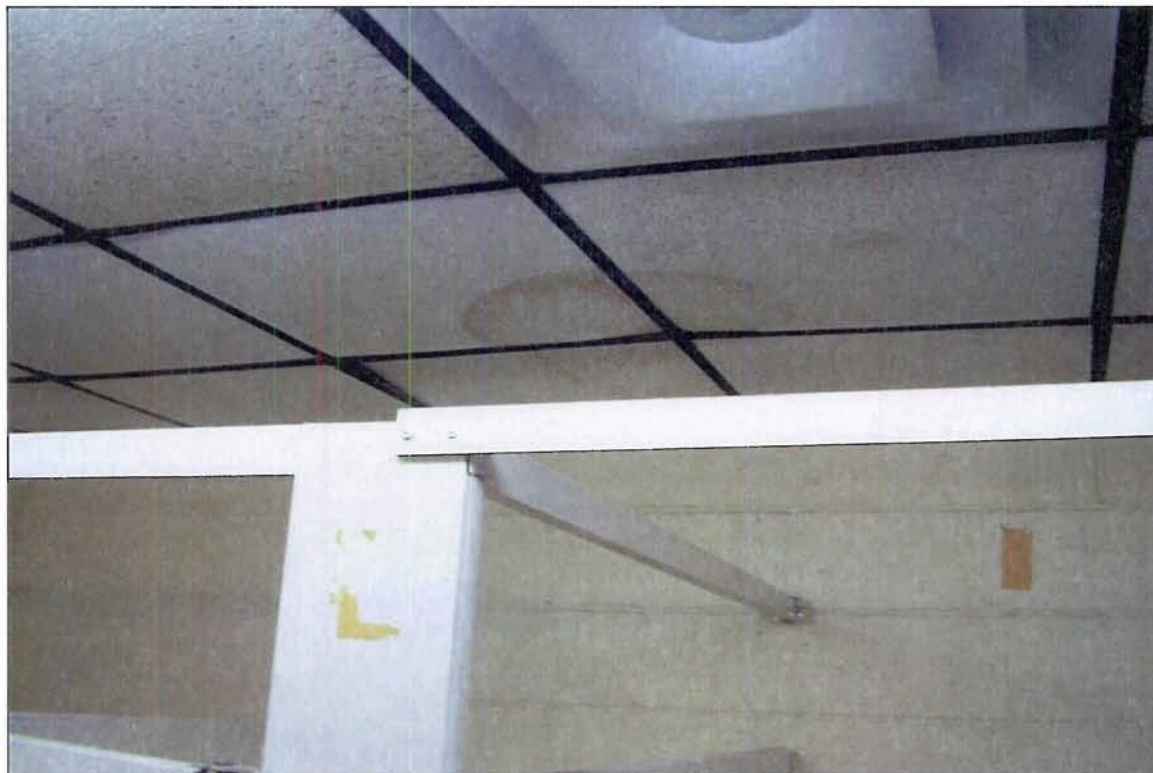
**Photo 28 - Stained Ceiling Tile In The Washroom**

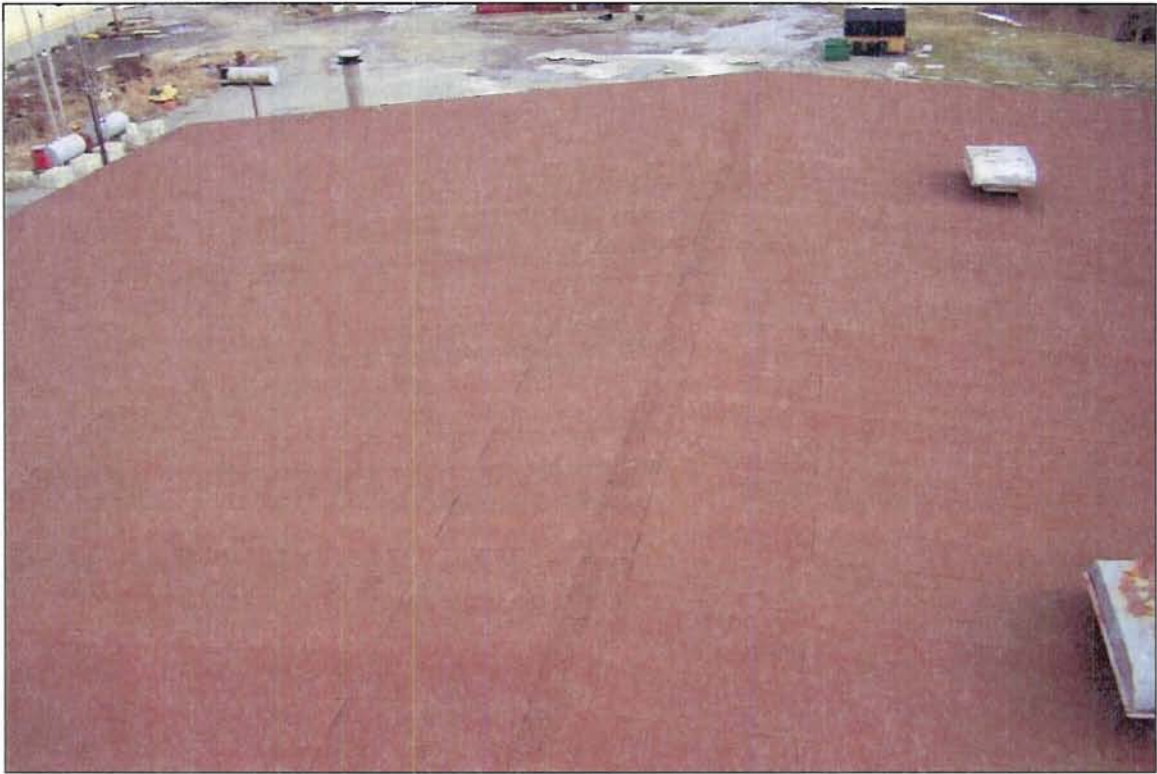
The new roof membrane was installed approximately three years ago and was observed to be in good condition overall. Roof curbs on all penetrations are installed and appear in good condition and finished using good construction practice. Some guy wire supports for mechanical/electrical equipment that are secured to the roof are rusted and lack proper sealants which may lead to leakage.

**Photo 29 - Typical Condition Of The Roofing Assembly**

- 1) Secure all equipment and guy wires properly, repair/replace worn or damaged fittings and reseal/caulk all roof penetrations. Provide regular inspection and repair.

This is a priority 2 recommendation with an opinion of probable cost of \$3,500.

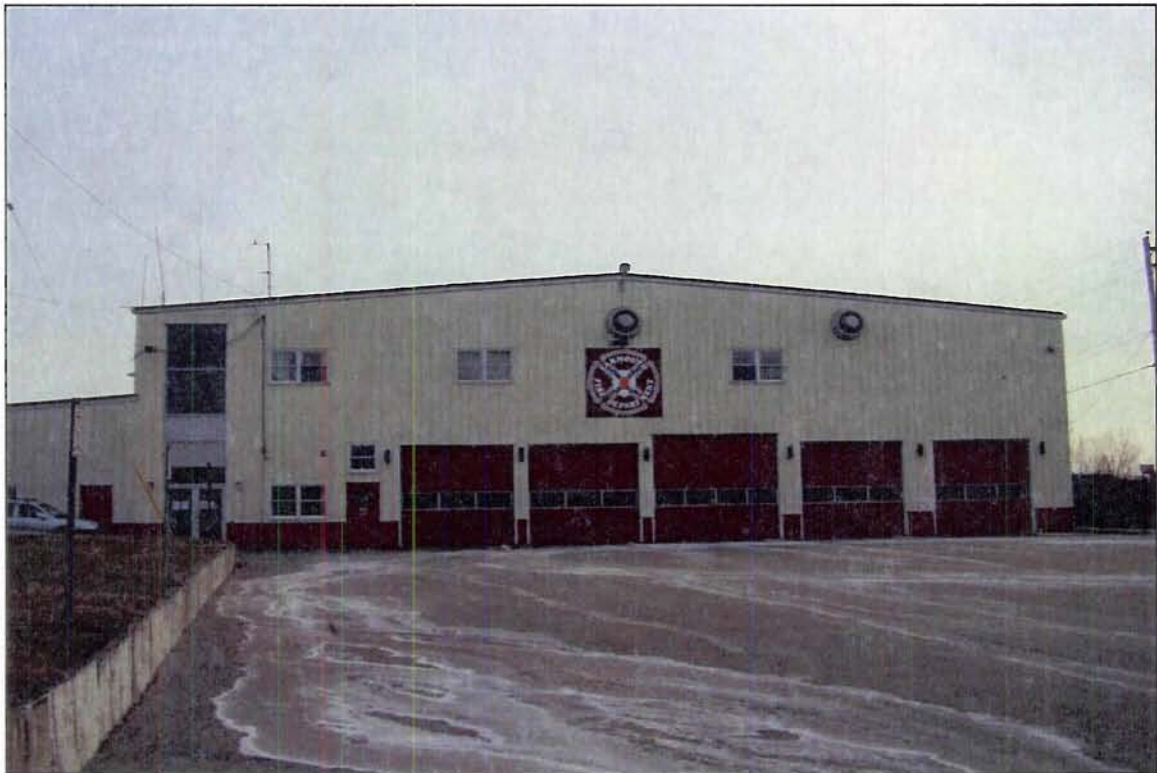
**Photo 30 - West Elevation Of The Yarmouth Firehall**
