*Final Report:*  
**Assessment of Options  
Killam Brothers Building**

*Prepared For:*  
**The Town of Yarmouth**

**Cantwell** Real Estate  
Planning  
Project Management  
& COMPANY  
February 2015

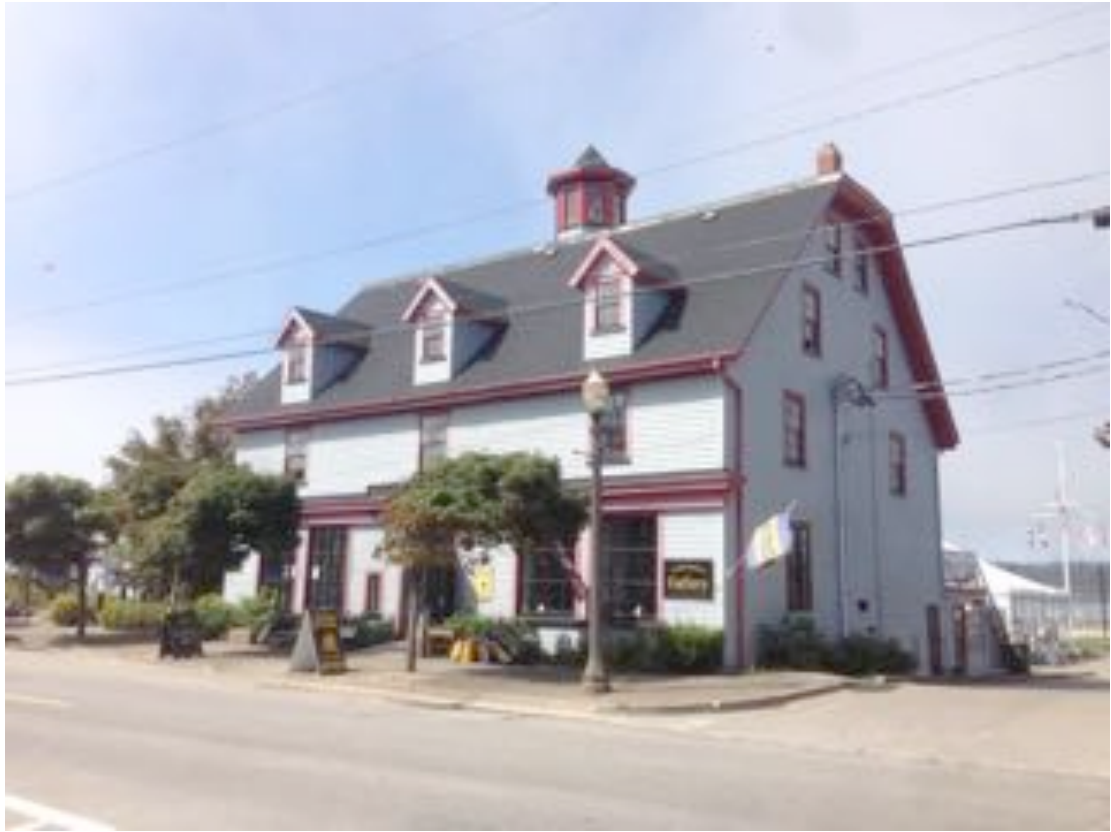
**Front of Building from Water Street**

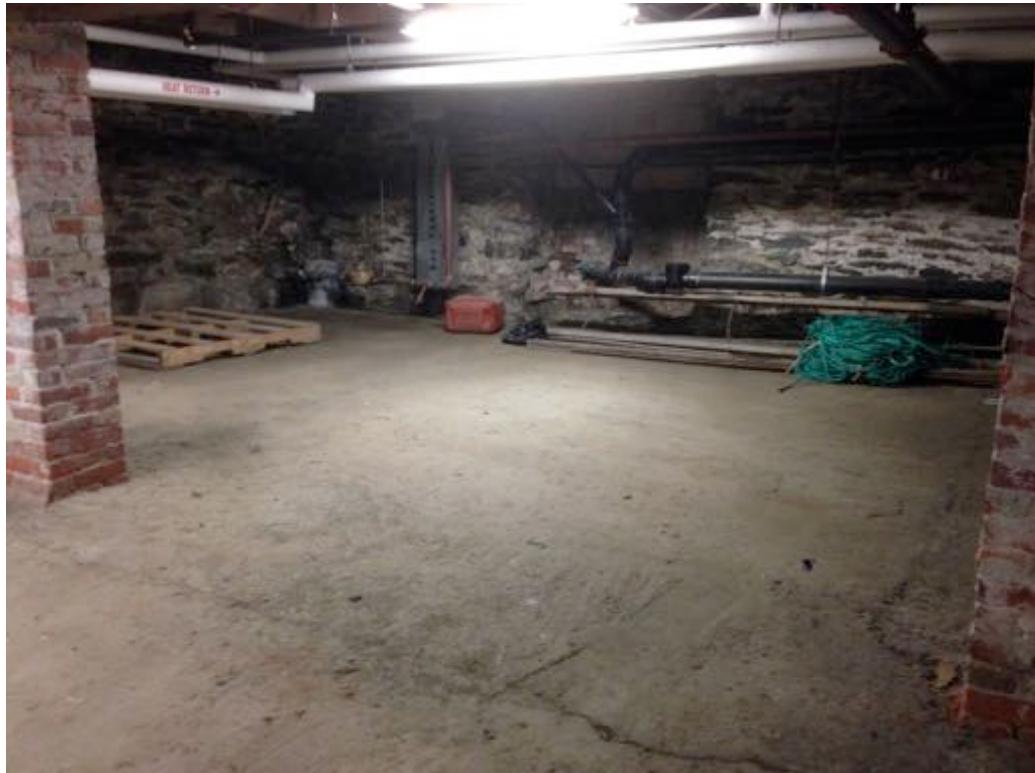
The Basement Has Limited Ceiling Height

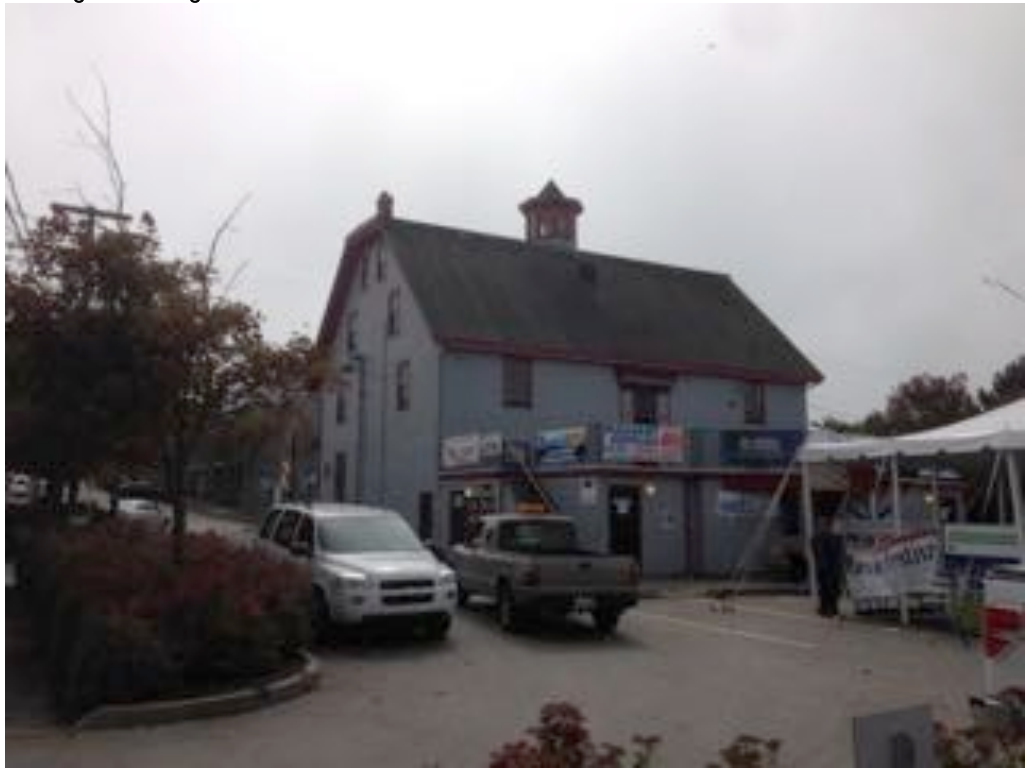
Rear of Killam Wharf Building: note washrooms below and deck above it
