**PHASE I and II
ENVIRONMENTAL SITE ASSESSMENT
CIVIC NO. 5 COLLINS STREET
YARMOUTH, NOVA SCOTIA**

December 4, 2009

MTL PROJECT NO. 10516

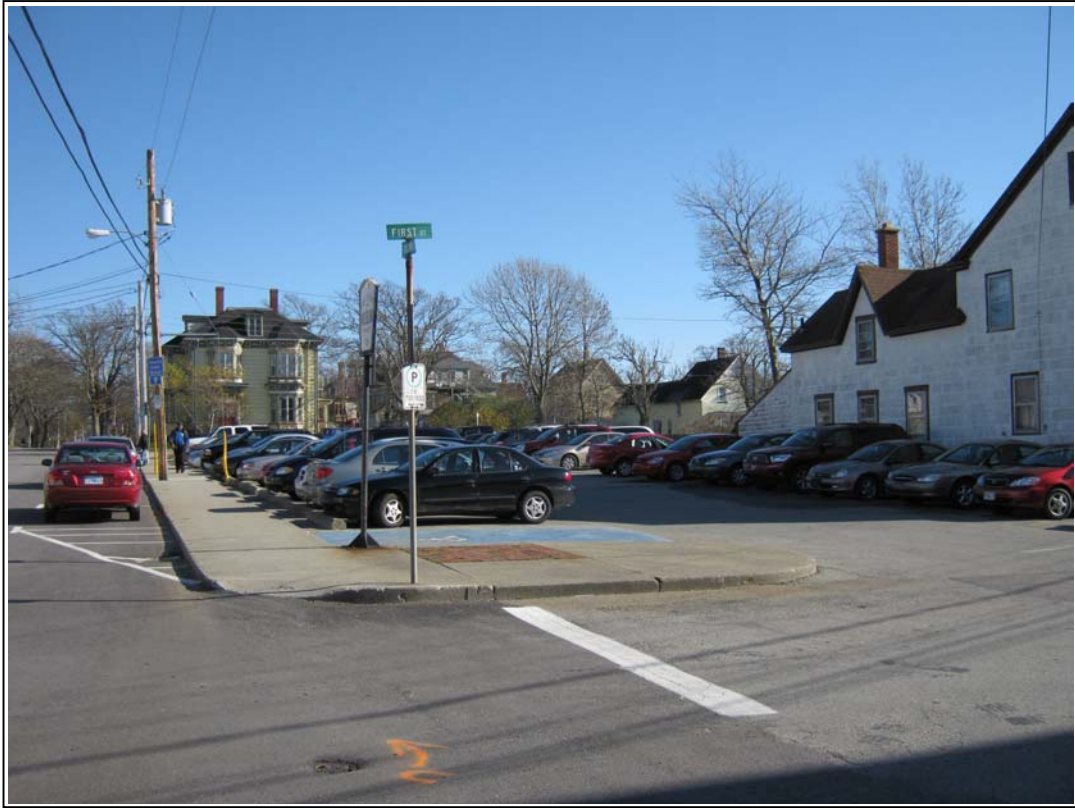
Photo 1: Taken November 9, 2009. Parking lot on the north portion of the subject property. An automotive service station occupied the northwest corner of the property until the 1970s. Photo taken facing east.

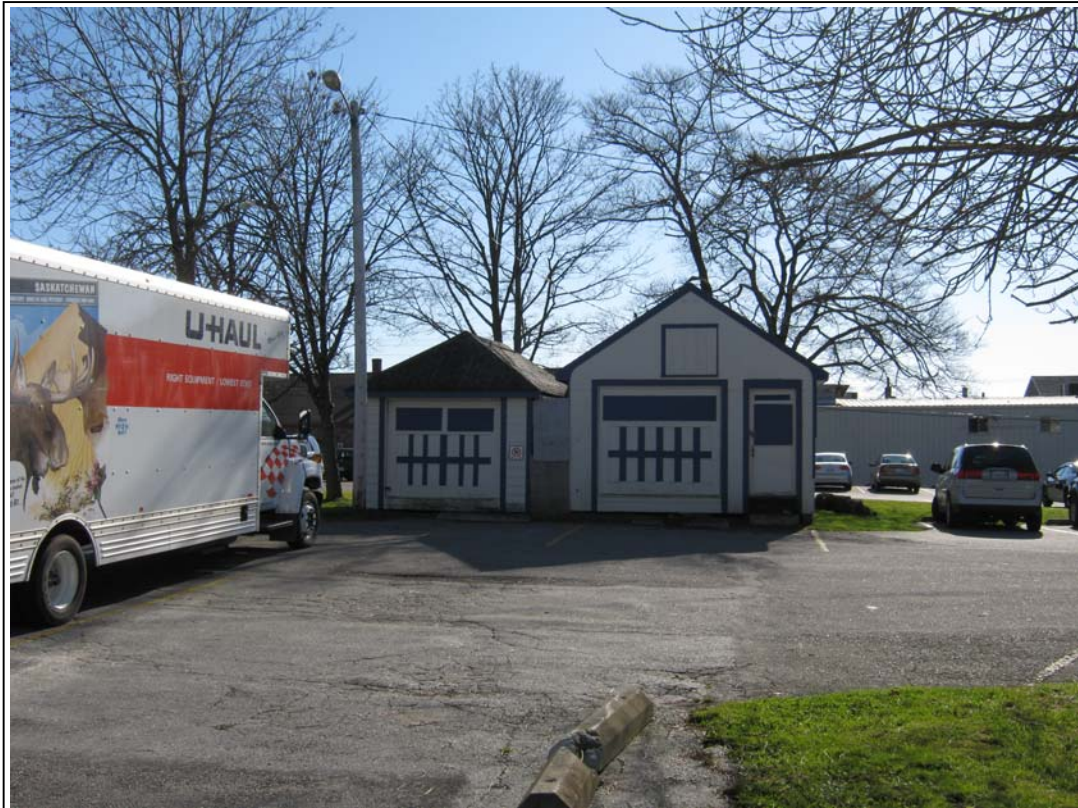
Photo 2: Taken November 9, 2009. Two small wooden buildings, located in the central portion of the subject property, are used by the Town of Yarmouth for storage of special events equipment (i.e., tables, holiday decorations, etc.). Photo taken facing south.

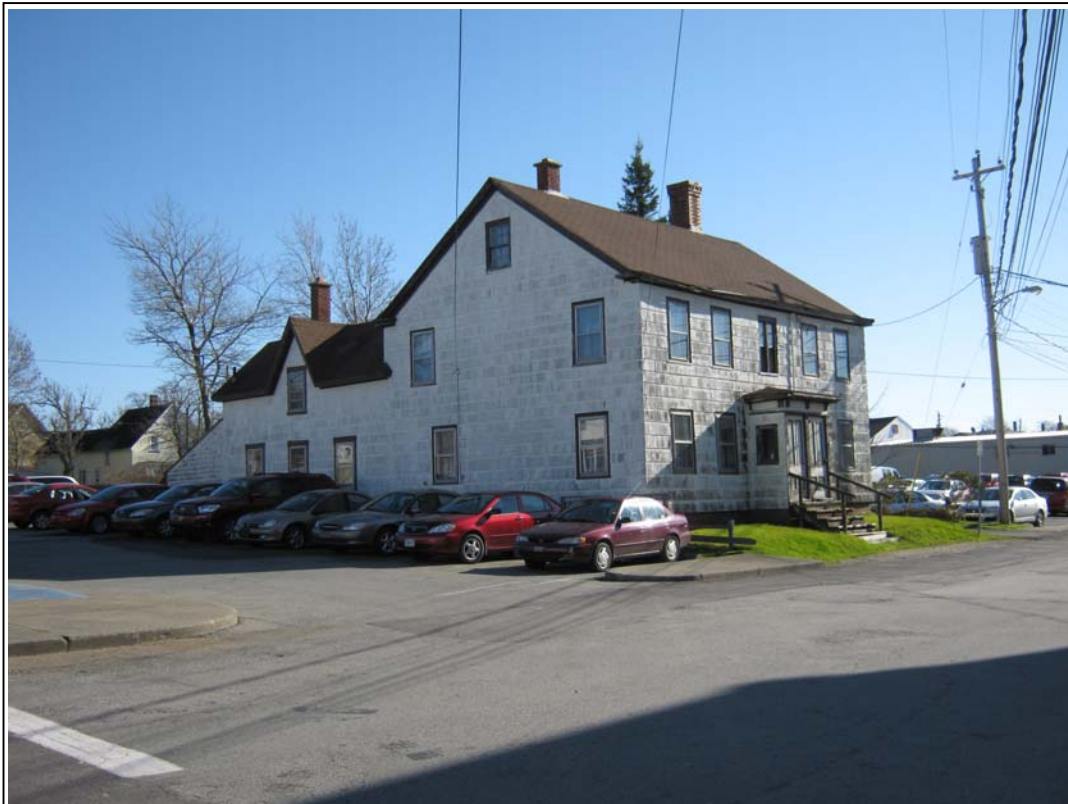
Photo 3: Taken November 9, 2009. A residential building (Civic Nos. 7 and 9 First Street) occupies a separate parcel on the west portion of the block of land occupied by the subject property. Photo taken facing southeast.

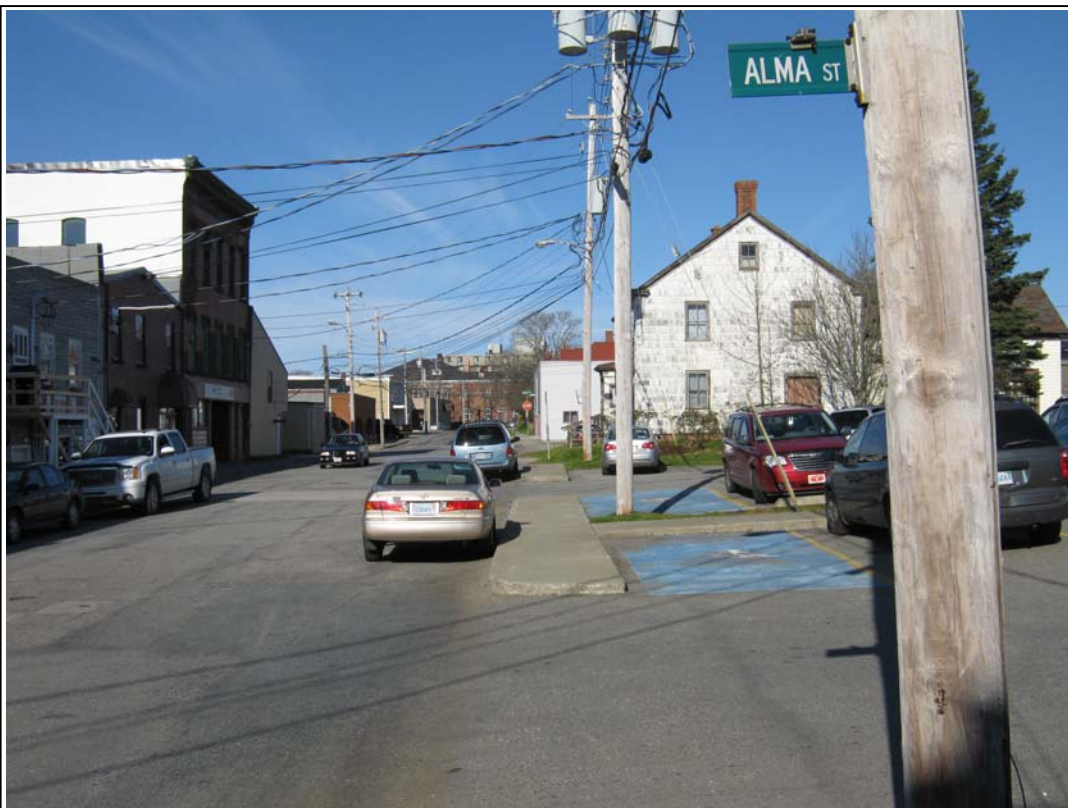
Photo 4: Taken November 9, 2009. Eastern portion of the subject property, along First Street. Note the commercial buildings located to the west, across First Street. Photo taken facing north.

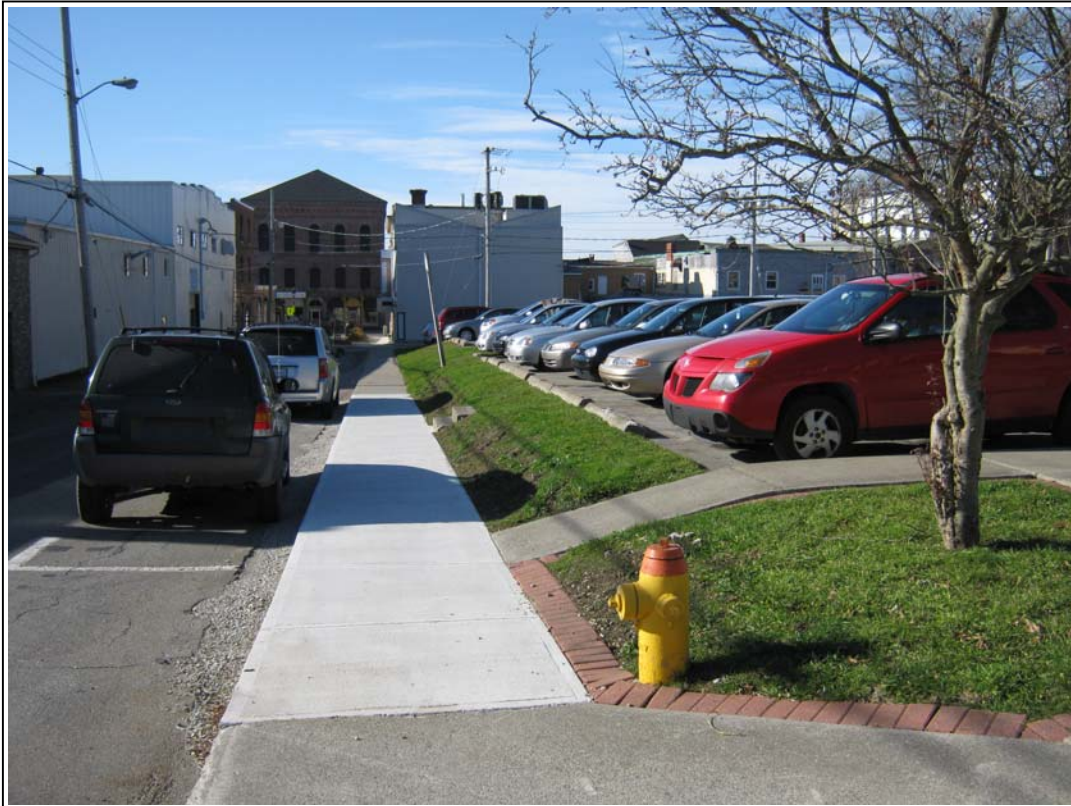
Photo 5: Taken November 9, 2009. Southern portion of the subject property, along Alma Street. The Yarmouth Vanguard (newspaper) offices and distribution center are located to the south across Alma Street. Photo taken facing west.
